# Service Campaign Bulletin

## Torque Checks and Pipe Protection Sleeve Installation

Document Number	14 A 001
Campaign Reference	04E
Affected Vehicles	720S
Date Released	21 <sup>st</sup> June 2017
Version	1

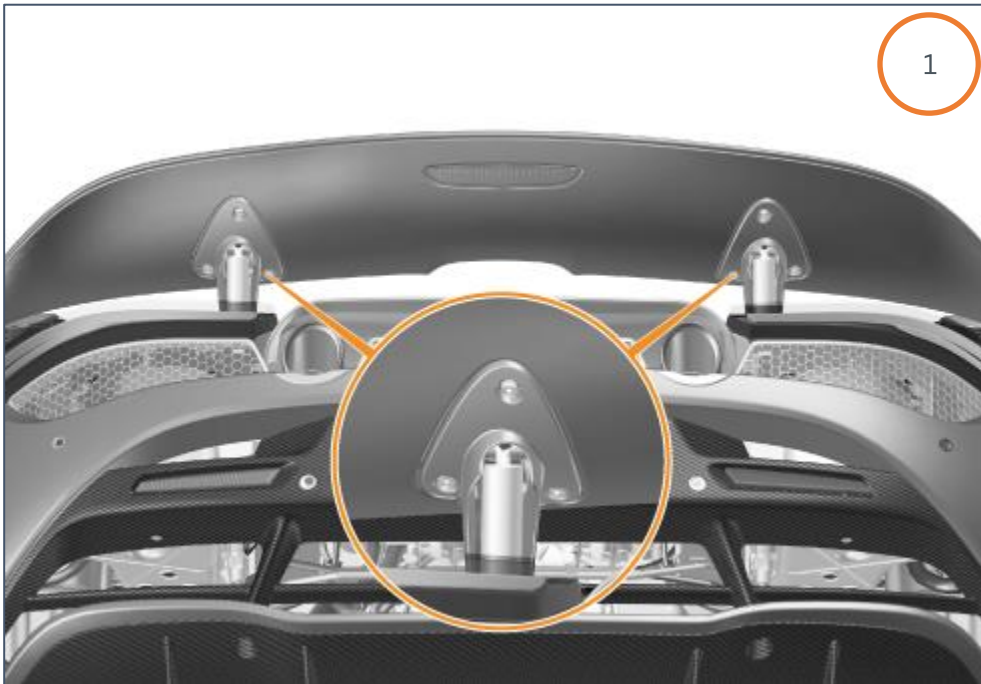
## Airbrake Panel Instructions

McLaren Automotive have identified a number of 720S vehicles released from production with potentially incorrect torque of the airbrake panel mounting bolts and both rear damper top fixings. As a result, Retailers are required to check the torque of these components. In addition, a clash condition between the starter harness and the oil feed pipe has been identified therefore a rubber pipe protector is required to stop potential noise.

1. Turn the ignition ON.
2. Press the ACTIVE button to switch on the active dynamics panel.
3. Press the AERO button to raise the airbrake panel.
4. Check the torque (14Nm) of the airbrake panel mounting bolts M6 x 18 (1). If one or more are found loose, retorque to the correct value 14Nm.
