Vehicles affected: P14: 720S, 720S Spider

Location: Powertrain - Engine

Concern: Rattle from engine bay

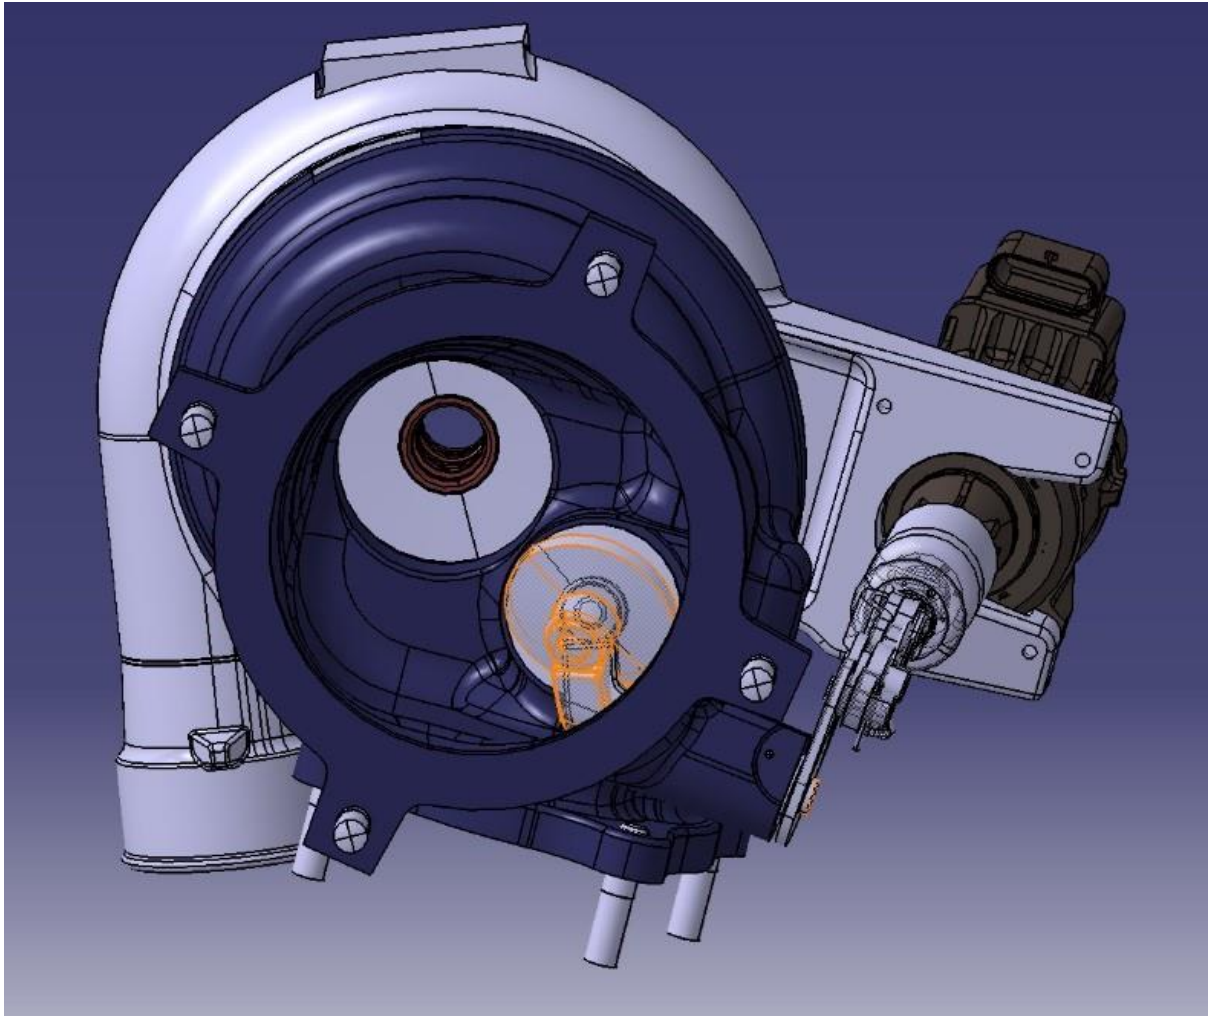
At engine speed up to 2500rpm it may be possible to hear a rattle noise coming from the engine bay area, especially if the door window is open.

The noise is more prevalent from the left hand side of the vehicle due to the orientation of the turbo.

This rattle is due to clearances within the turbo wastegate valve assembly - highlighted in the image below - and is present when the wastegate valve is in the open position.

At 1800rpm the wastegate valve will be held closed, which reduces the audible rattle.

These clearances are required to allow for heat expansion of the multiple materials used and their different heat expansion rates.

As a result of this design, the tolerance cannot be changed and the resultant rattle is a characteristic of the assembly design.
