Vehicles affected: P14: 720S

Location: Body BIW - Panels

Concern: Rear Bodyside Lower Panel Misalignment

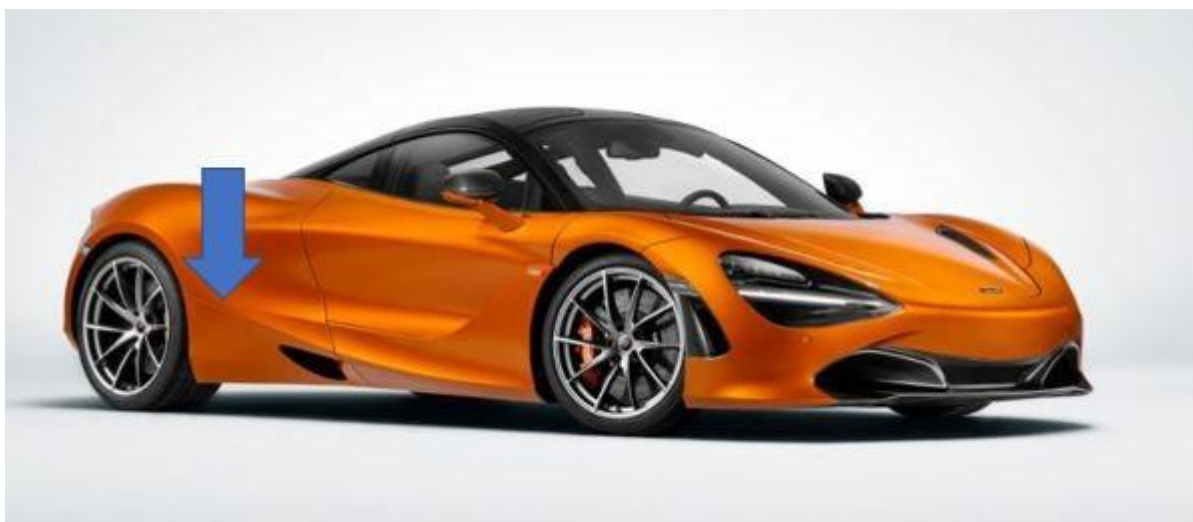
Under hot temperature conditions (engine temperature and/or ambient temperature) the rear bodyside lower panel can get deformed/misaligned to the rest of the body side as shown in the picture below. Follow the steps outlined in this document to correct this condition.

1. Remove the rear bodyside lower panel as per SIS instructions DA-RM-02A051-03-002 - Remove/Install bodyside - Lower
2. Ensure all clips to the bodyside are secure. Replace if required.
3. Inspect all 3 bolts to ensure correct length (M6 x 12). If the rear bolt is longer this may result clashing with the rear bodyside lower panel.
4. Install the panel and ensure the correct torque is used as per SIS. Excessive torque may cause panel deformation.
