Vehicles affected: P14: 720S Coupe, 720s Spider

Location: Body BIW - Panels

Topic: Rear Bodyside Lower Panel Misalignment

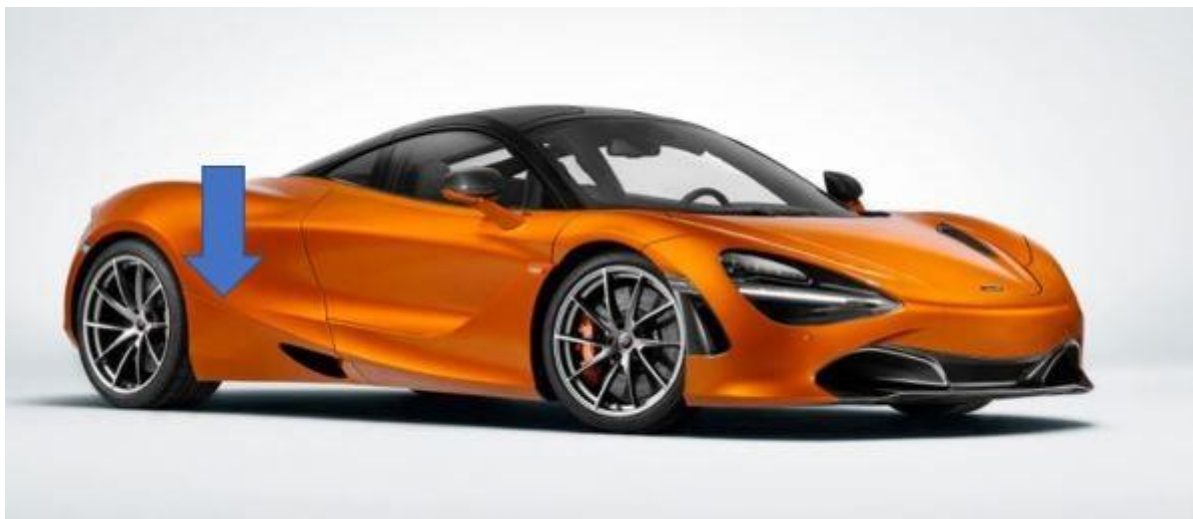
Under hot temperature conditions (engine temperature and/or ambient temperature) the rear bodyside lower panel can get deformed/misaligned to the rest of the body side as shown in the picture below. Follow the steps outlined in this document to correct this condition.

1. Remove the rear bodyside lower panel as per SIS instructions DA-RM-02A051-03-002 - Remove/Install bodyside - Lower
2. Ensure all clips to the bodyside are secure. Replace if required.
3. Inspect all 3 bolts to ensure correct length (M6 x 12). If the rear bolt is longer this may result clashing with the rear bodyside lower panel.
4. Install the panel and ensure the correct torque is used as per SIS. Excessive torque may cause panel deformation.
