Vehicles affected: P14: 720S, 720S Spider

Location: Body BIW - Panels

Concern: Upper bodyside rear panel not aligned with the door

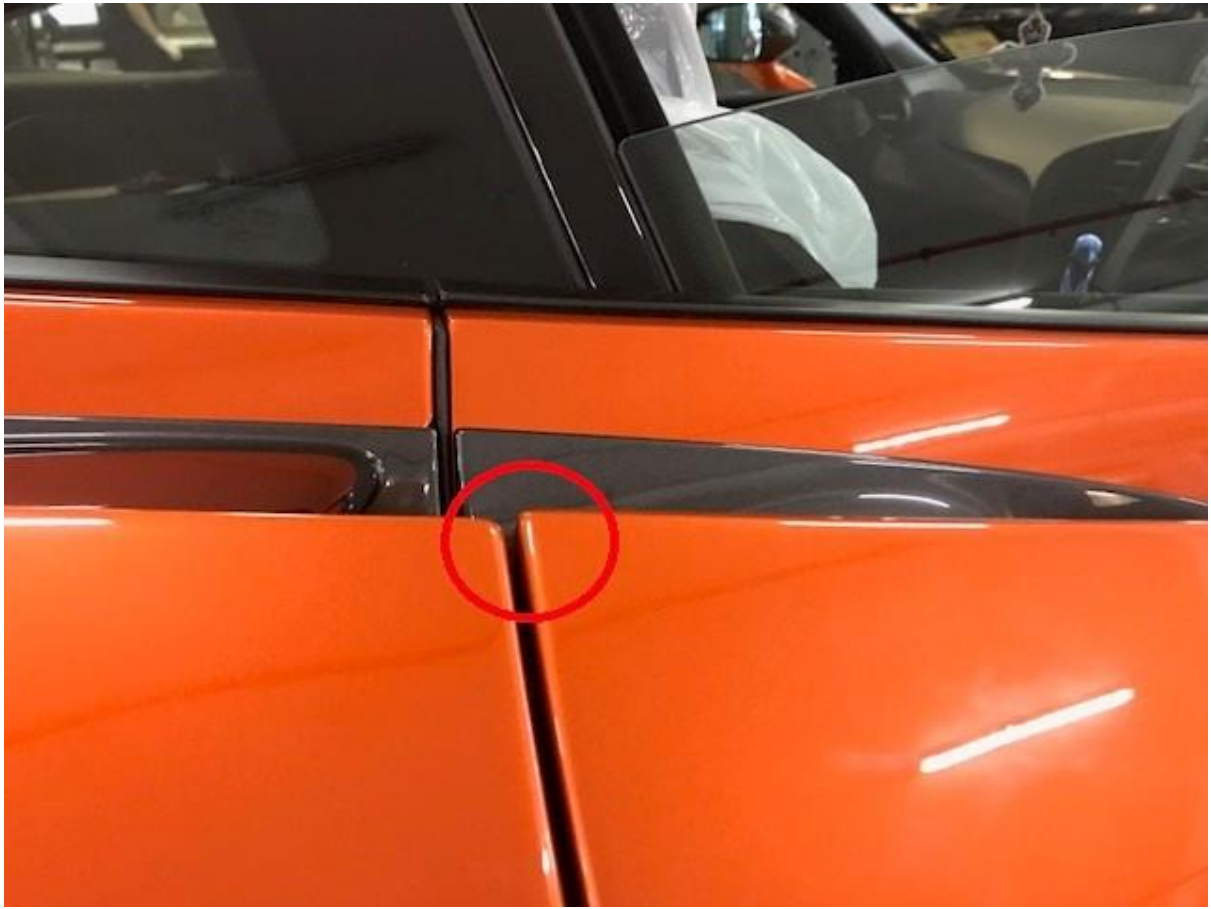
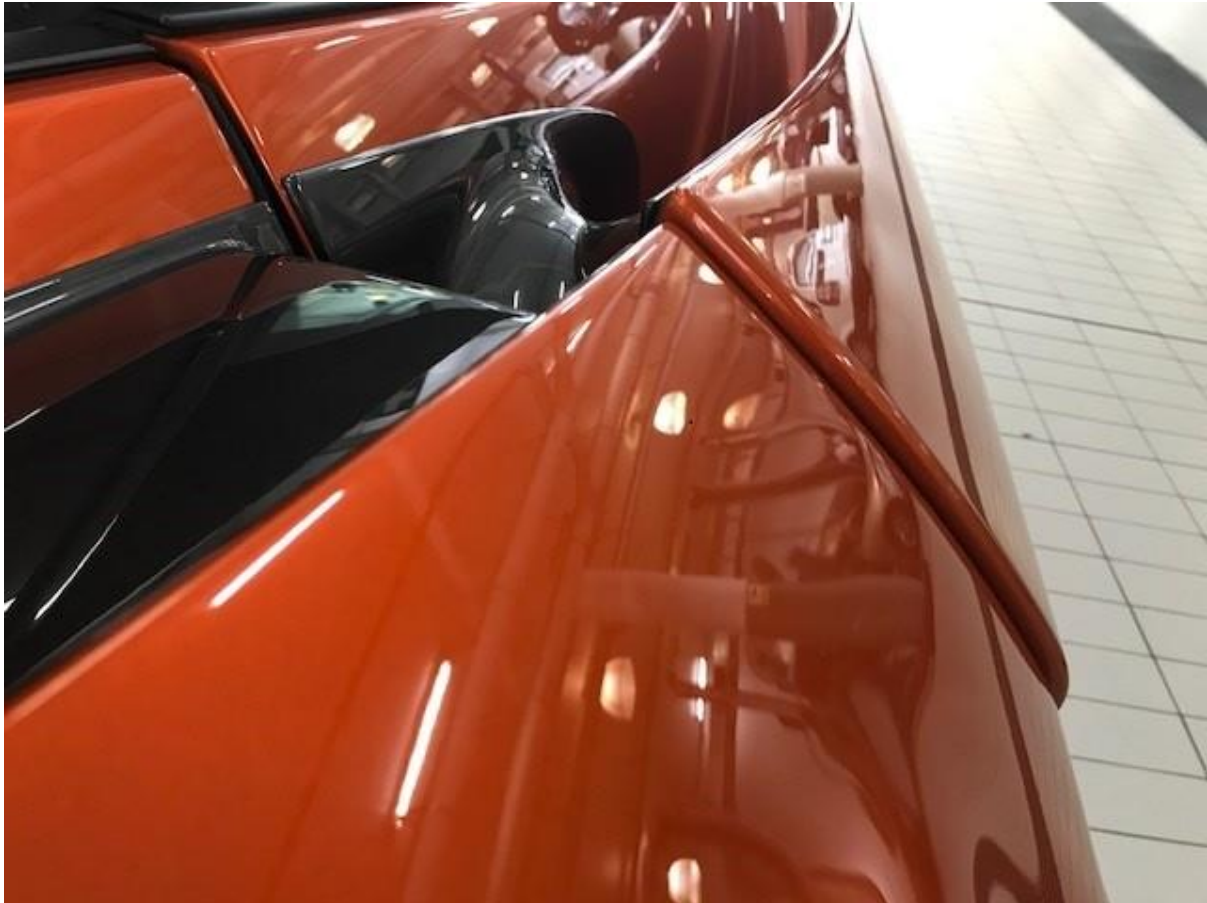
If you experience an under flush condition of the rear bodyside upper, as outlined in the pictures below, then follow the instructions enclosed to assist you adjusting the rear body panel.
