Location: Infotainment - ADI

Topic: FM/AM Radio Reception Diagnosis

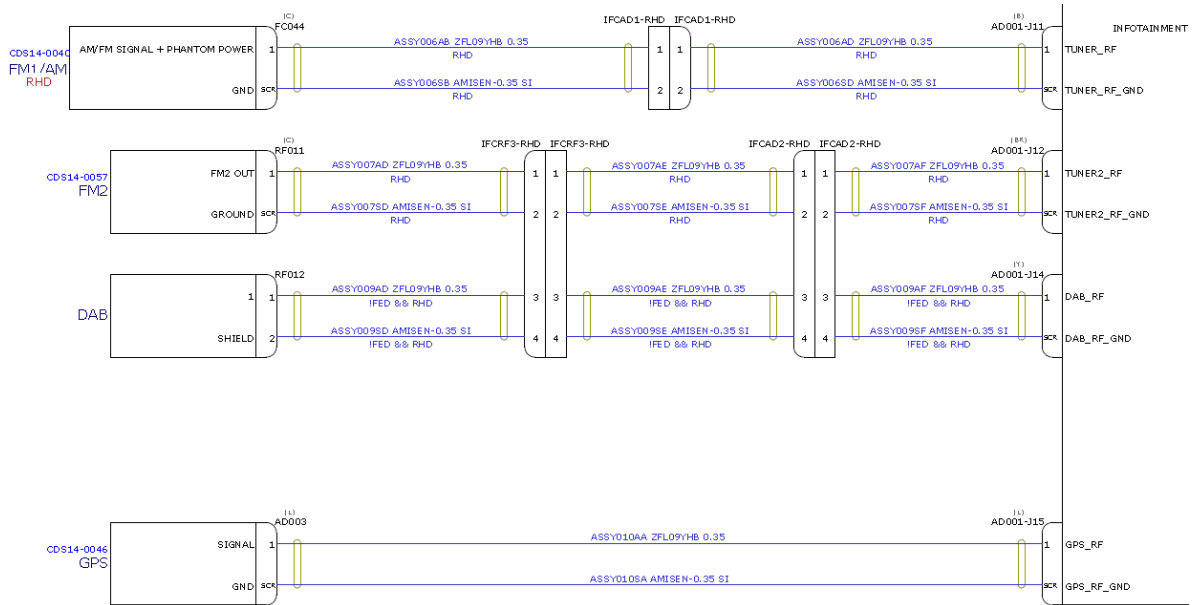
**Right Drive EU**

6. If Coax cable is open circuit or with very high resistance, or short circuit to ground make an inspection of the intermediate connections that separate harness sections (see wiring diagram below).

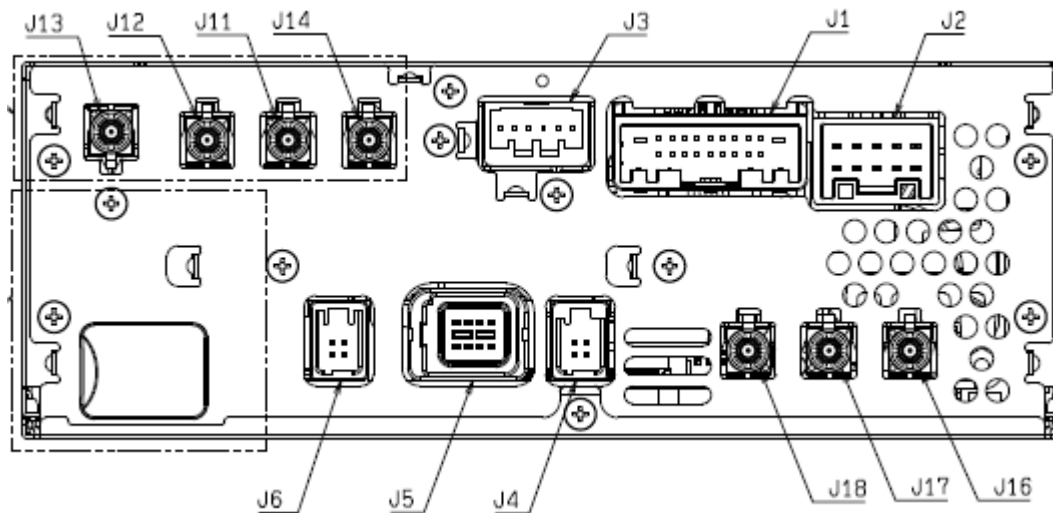
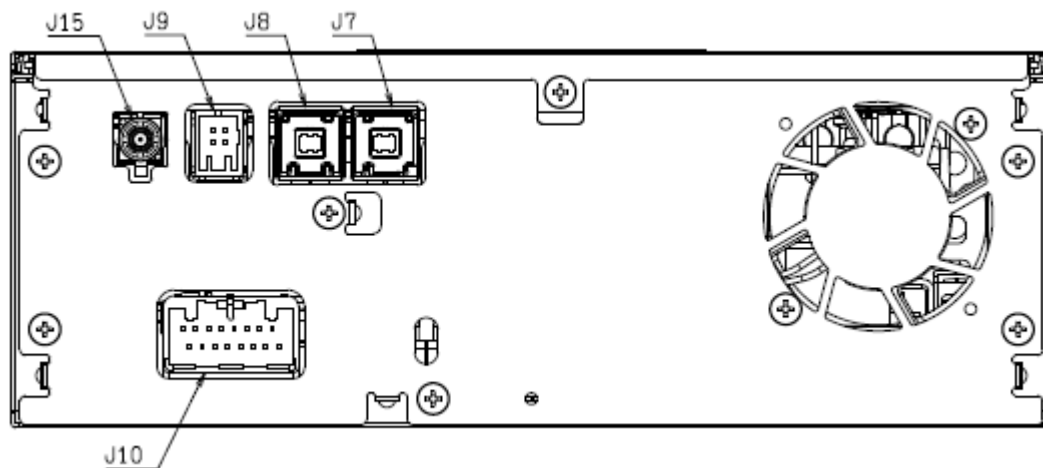
## Infotainment (ICU)

4. If the connections are good check the Fakra connections at the ICU.
5. If the Fakra connections are good, disconnect each end of the relevant coax cable from the amplifier and ICU (See table below) and using a multimeter make continuity tests.
