**Location:** Chassis - Suspension

**Topic:** Multiple warnings on the driver's display and unable to use nose lift and perform mode changes.

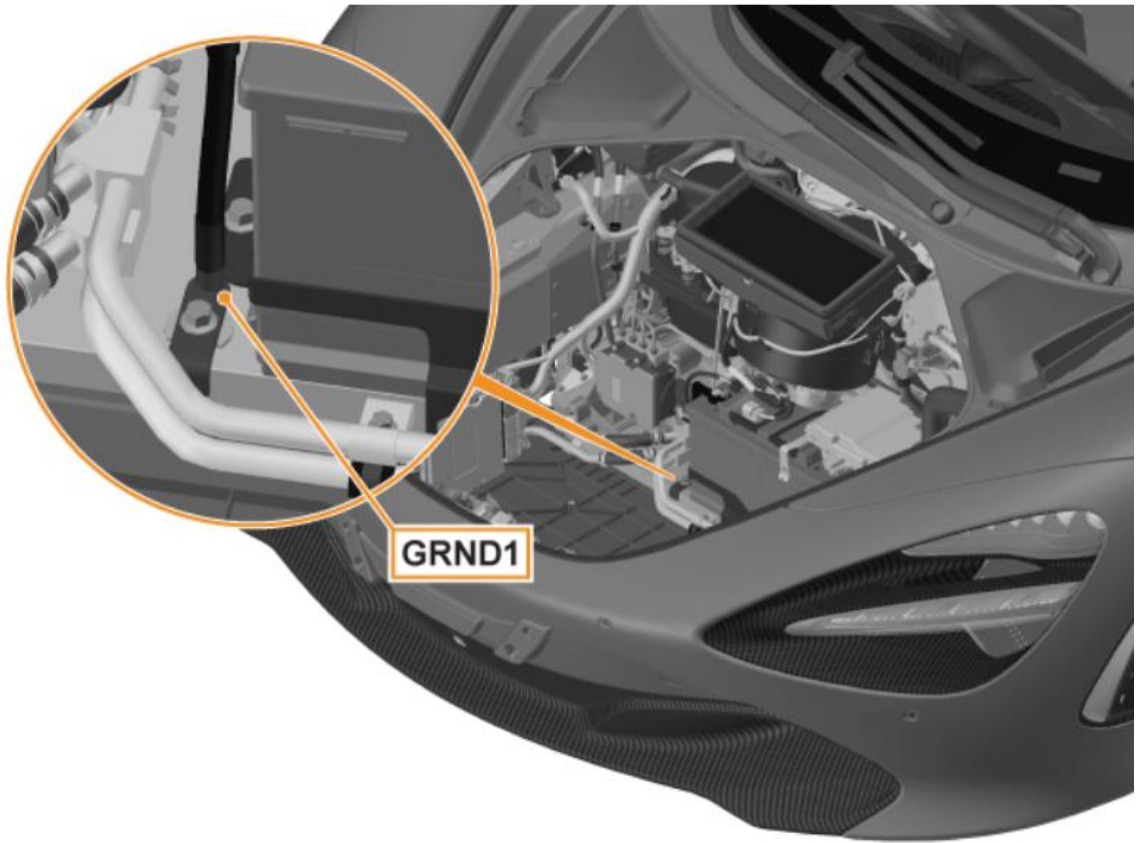
GRND1

Poor ground(s) contact may have caused the CCU to remain in sleep and as a result most of the powertrain and chassis control units have lost communication with CCU.

3. Remove ground point and clean contact surfaces.
4. Reinstall all three ground points.
5. Clear all DTCs with the MDS.
6. Ensure the 12V battery is fully charged.
7. Check the operation of the vehicle.
