**Location:** Body Exterior - Exterior Ornamentation

**Topic:** Rear bumper exhaust heatshield coming loose

**Condition:** Heat from the exhaust

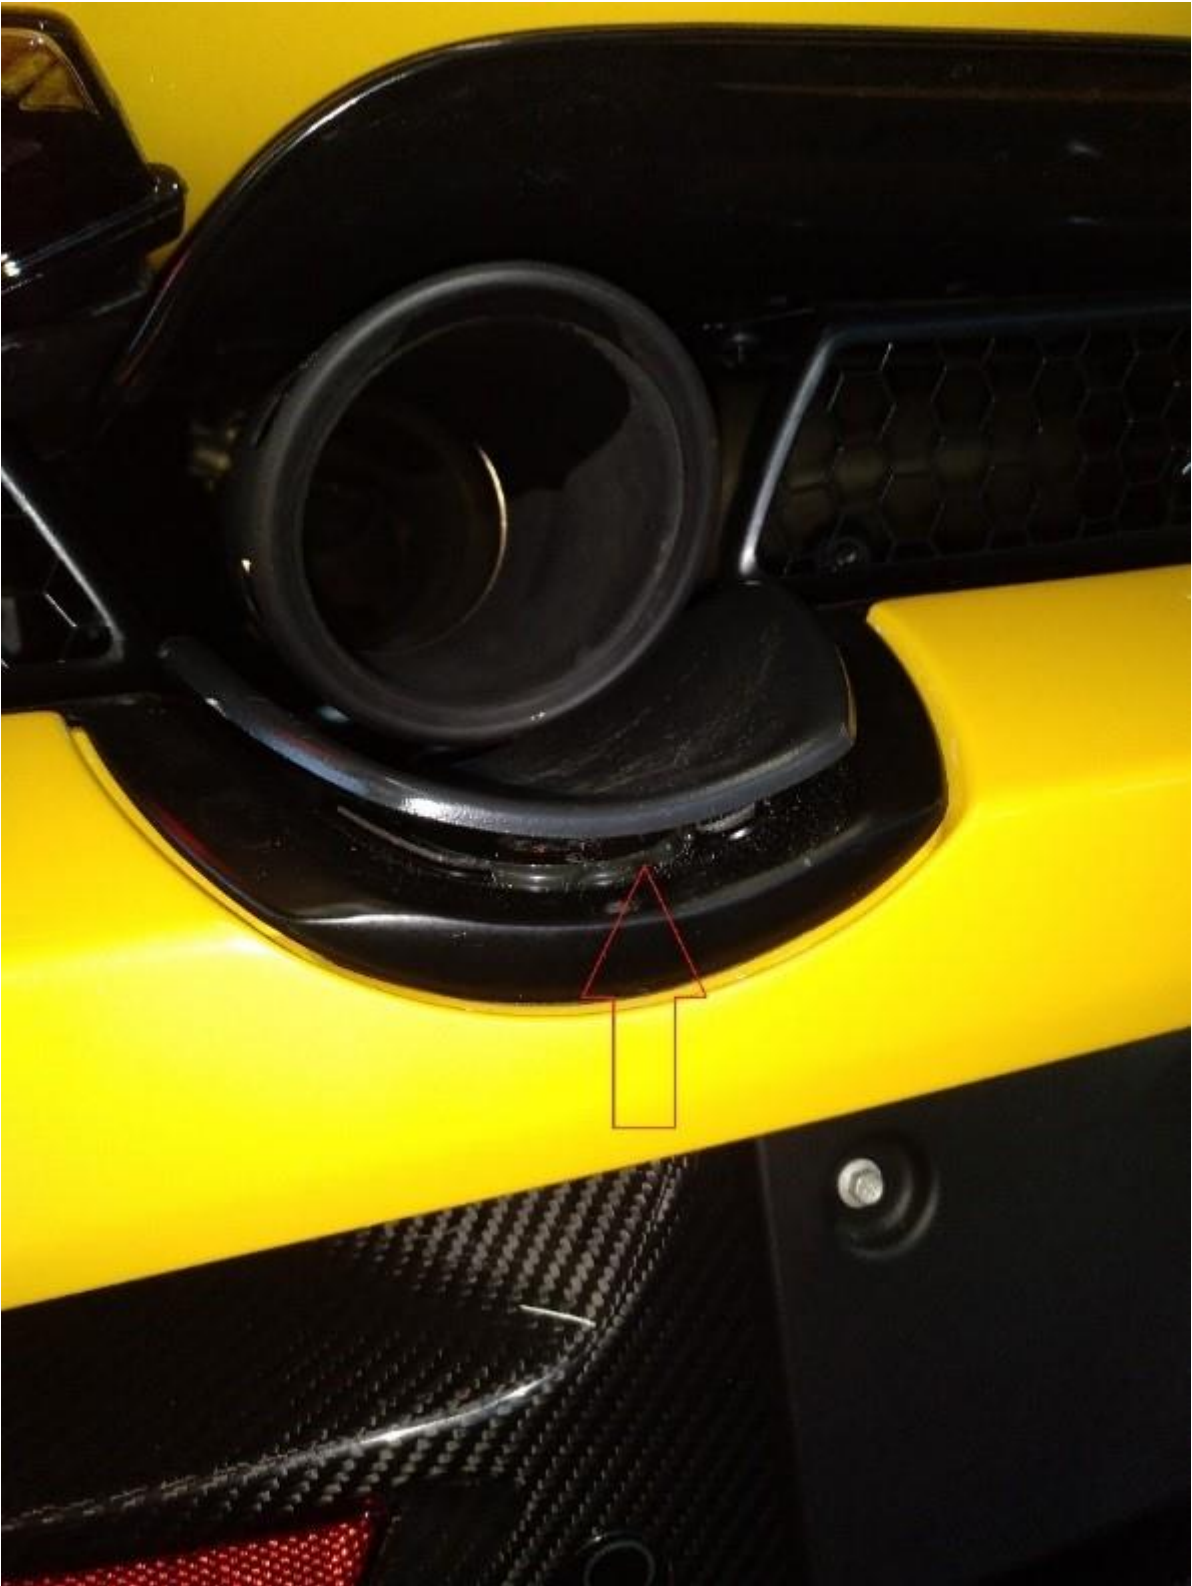
On early production 720S vehicles, the exhaust heatshield on the rear bumper may come lose.

This is due to the adhesive used to install this part to the bumper not being appropriate for this application (high temperature).

This document explains how to repair this concern with new parts and installation method.

A new design of the exhaust heatshield has now been introduced. The new heatshield now has 2 studs an inner and an outer one to secure it on the rear bumper extension.
