Vehicles affected: P14: 720S, 720S Spider

Location: Electrical – Infotainment (ADI)

Concern: ADI Update Failure

Condition: ADI screens unresponsive and stuck in system update screen

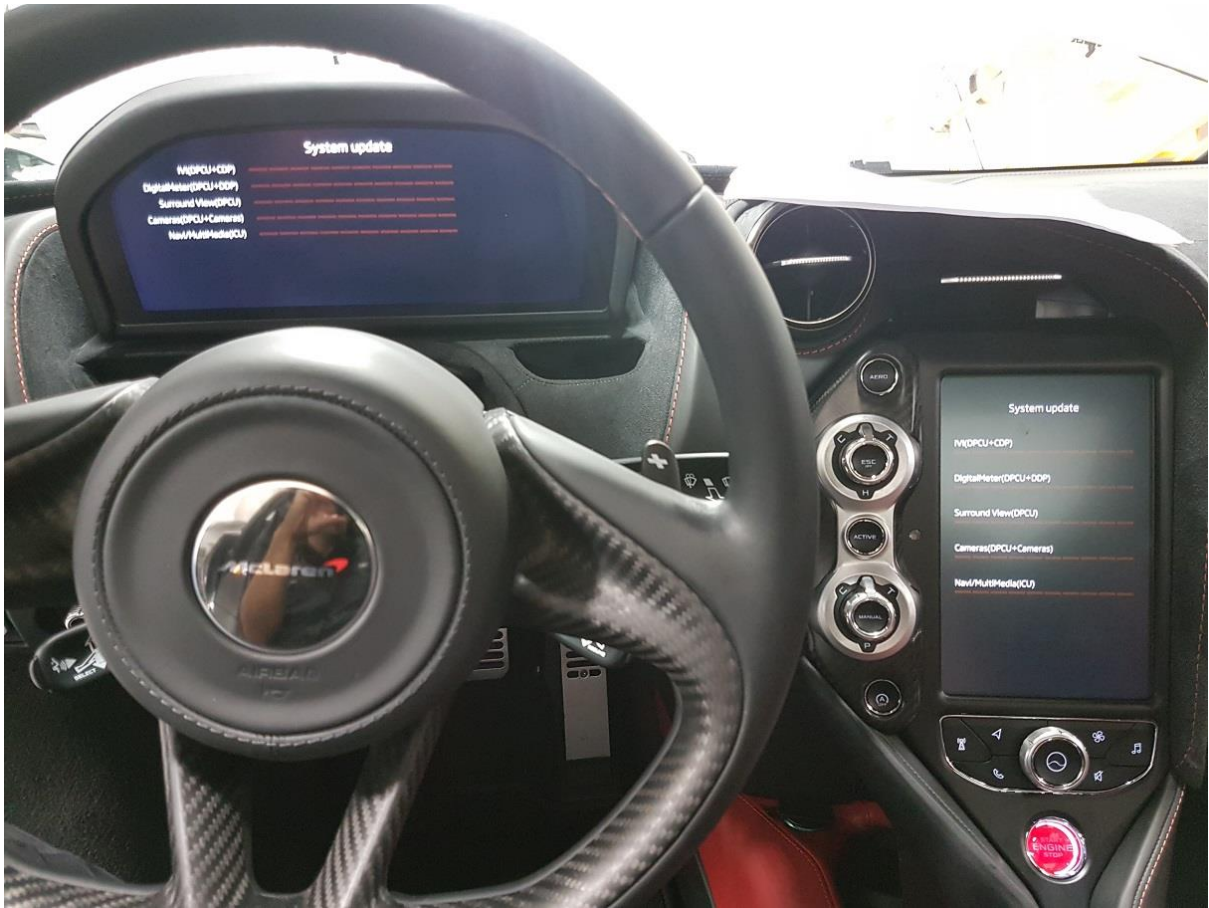
It is possible that an ADI Software Update can fail before successful completion. This will result in both the ADI screens being frozen and showing 5 Update Progress Bars continuously, see picture below.

This condition will not change even after an ignition cycle or a battery reset is carried out.

1. Download the zip file attached to the following link: <http://we.tl/t-bH4WmNXBFO> (Password: McLarenADI)
2. Extract the 3 files contained inside the zip file directly to a blank USB stick (USB stick size between 1-8GB) that is formatted to FAT32. You should have 3 files on their own, directly on the USB - do not create any folders inside the USB
3. Turn Off the ignition (ISO or IS1)
4. Remove any USB stick from the ADI USB ports (if previously plugged in)
5. Disconnect the 12V battery
6. Remove the DPCU and ICU fuses:

a) DPCU - F23 (5A Mini - Footwell Fusebox)

b) ICU - F24 (20A Mini - Electric City Fusebox)

7. Wait for 5 minutes

8. Insert the DPCU and ICU fuses back

9. Reconnect the 12V battery

10. Set the ignition to state 5 - to ensure the car is in ignition state 5 you should be able to hear the throttle valves when pressing the accelerator pedal

11. Wait until the system has fully booted up (both screens displaying the system update bars)

12. Wait for 5 minutes

13. Plug in the USB stick (created in step 2) into the USB port 2

14. At this stage the ADI will start downloading data from the USB. The ADI screens will continue to display the System Update progress bars and it will appear as if nothing is happening. It may take a considerable amount of time until this step is completed. Please allow enough time during this step while ensuring the vehicle does not go to sleep

15. Once the system has downloaded the data from the USB the progress bars should start loading again. This indicates that the ADI software update has restarted and is now in progress once again

16. If this recovery attempt fails repeat steps 1 to 15 but in step 13, plug the USB into the other port - USB port 1
