Vehicles affected: P14: 720S, 720S Spider

Location: Electrical – Infotainment (ADI)

Topic: ADI Update Failure

Condition: ADI screens unresponsive and stuck in system update screen

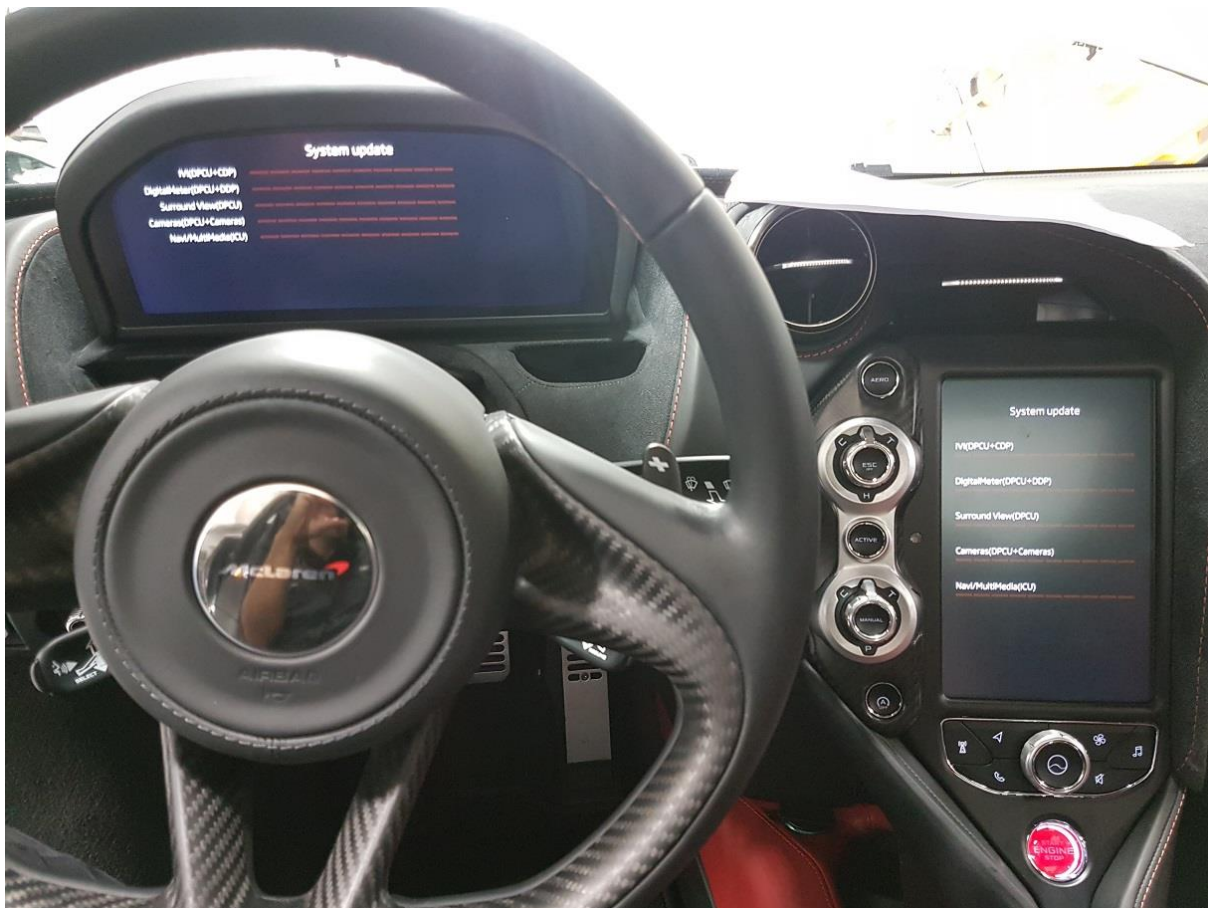
It is possible that an ADI Software Update can fail before successful completion. This will result in both the ADI screens being frozen and showing 5 Update Progress Bars continuously, see picture below.

This condition will not change even after an ignition cycle or a battery reset is carried out.

To attempt recovery of the system please follow the steps outlined below:

1. Download the zip file
2. Extract the 3 files contained inside the zip file directly to a blank USB stick (USB stick size between 1-8GB) that is formatted to FAT32. You should have 3 files on their own, directly on the USB - do not create any folders inside the USB
3. Turn Off the ignition (ISO or IS1)
4. Remove any USB stick from the ADI USB ports (if previously plugged in)
5. Disconnect the 12V battery
6. Remove the DPCU and ICU fuses:
 - a) DPCU - F23 (5A Mini - Footwell Fusebox)

b) ICU - F24 (20A Mini - Electric City Fusebox)

7. Wait for 5 minutes
8. Insert the DPCU and ICU fuses back
9. Reconnect the 12V battery
10. Set the ignition to state 5 - to ensure the car is in ignition state 5 you should be able to hear the throttle valves when pressing the accelerator pedal

11. Wait until the system has fully booted up (both screens displaying the system update bars)
12. Wait for 5 minutes
13. Plug in the USB stick (created in step 2) into the USB port 2

14. At this stage the ADI will start downloading data from the USB. The ADI screens will continue to display the System Update progress bars and it will appear as if nothing is happening. It may take a considerable amount of time until this step is completed. Please allow enough time during this step while ensuring the vehicle does not go to sleep

15. Once the system has downloaded the data from the USB the progress bars should start loading again. This indicates that the ADI software update has restarted and is now in progress once again

16. If this recovery attempt fails repeat steps 1 to 15 but in step 13, plug the USB into the other port - USB port 1
