Vehicles affected: P14: 720S, 720S Spider

Location: Powertrain - Engine

Concern: Rattle from engine bay

Condition: Idle to 2500rpm

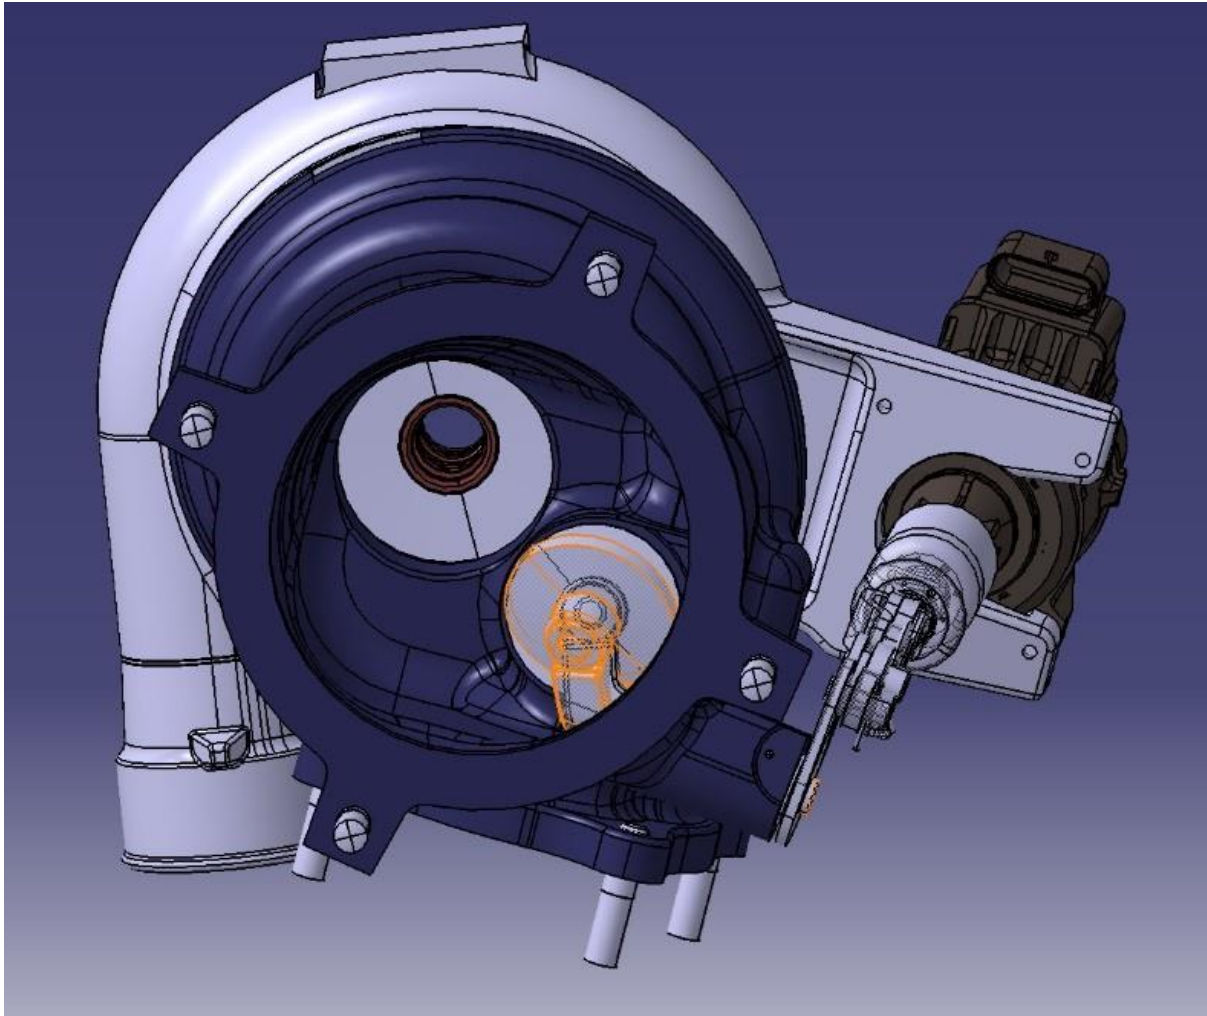
This rattle is due to clearances within the turbo wastegate valve assembly - highlighted in the image below - and is present when the wastegate valve is in the open position.

These clearances are required to allow for heat expansion of the multiple materials used and their different heat expansion rates.

As a result of this design, the tolerance cannot be changed and the resultant rattle is a characteristic of the assembly design.
