Vehicles affected: P14: 720S, 720S Spider

Location: Body Exterior - Closures Ancillaries

Concern: Clash condition between door and front fender

Condition: When the door is fully open

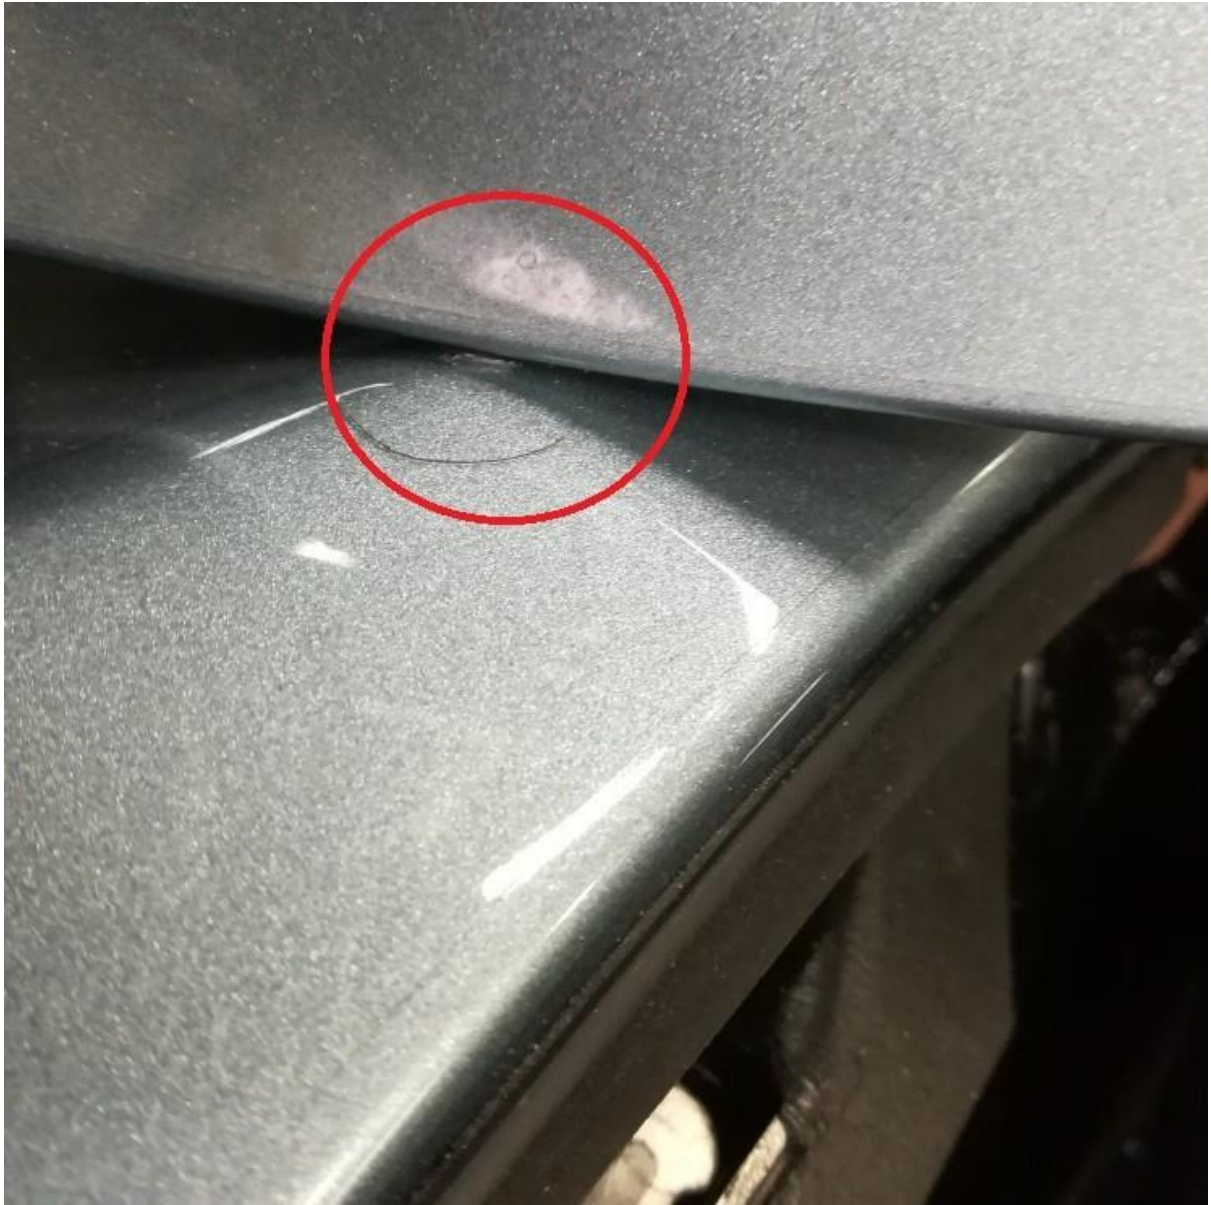
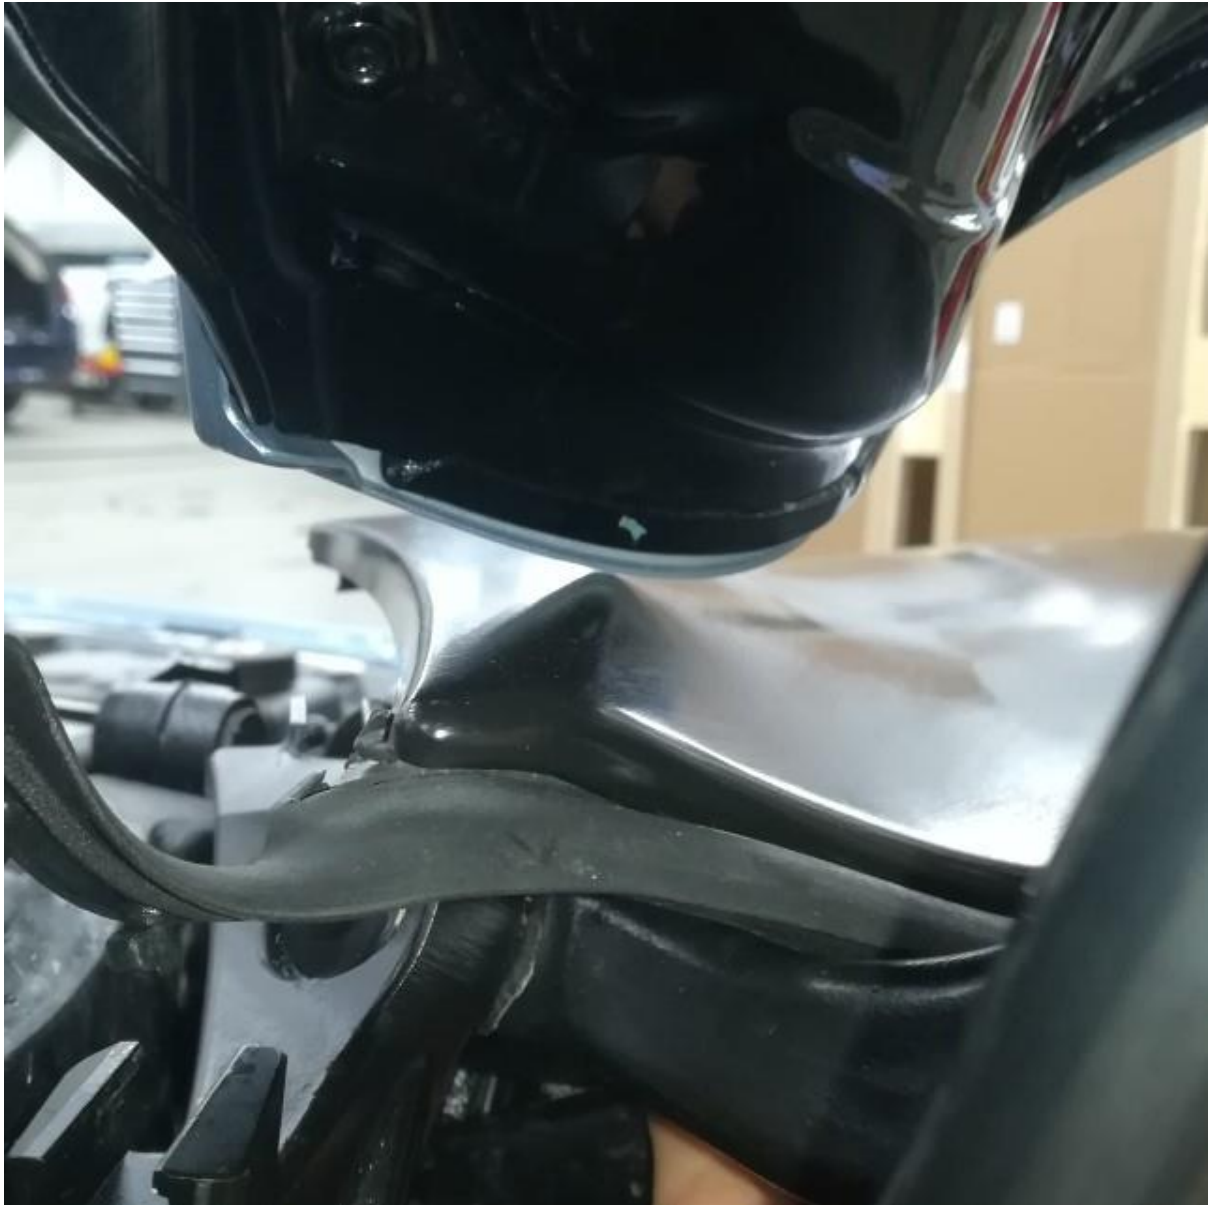
A potential clash condition between the front fenders and the doors when they are fully open has been identified.

If you receive a vehicle with this concern, order and fit new door gas strut(s) as per the part number supplied in the Parts Information section of this document.

The new door gas strut is shorter limiting the maximum door travel and thus eliminating the clash condition.

Once the installation of the new part is completed, refer to SIS to check gap and flush of fender to door and bonnet.
