Powertrain - Engine - Engine: P14: 720S, 720S Spider. Lack of Power from the engine due to loose plastic baffle inside the air intake pipework

Vehicles affected: P14: 720S, 720S Spider

Concern: Lack of power / Engine Warning Light / Noise

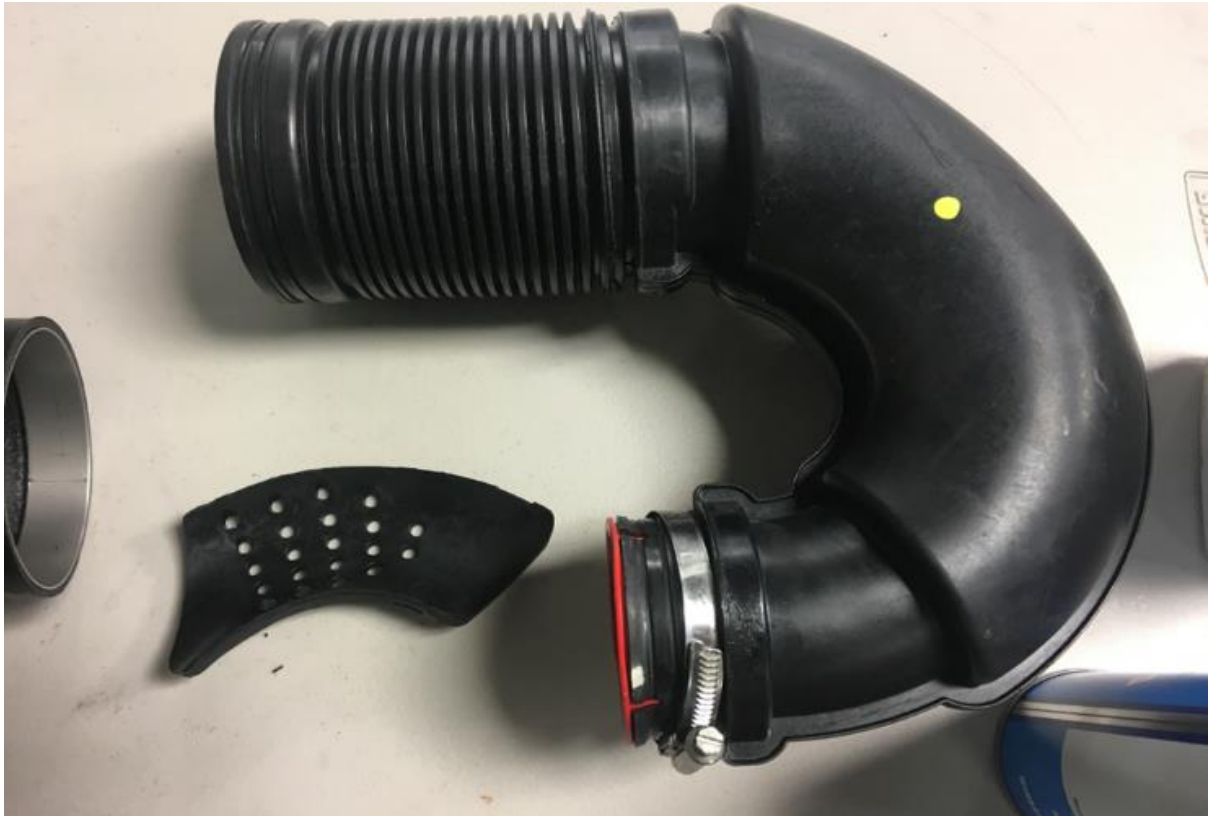
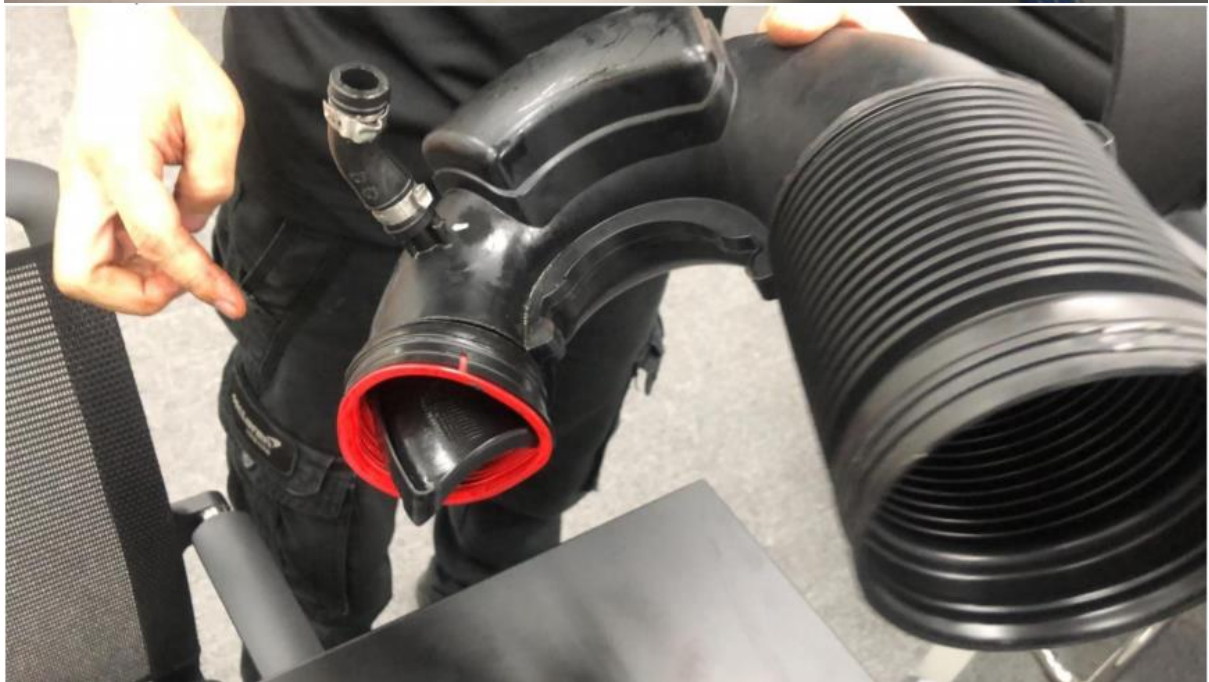
When diagnosing power loss from the engine and boost issues with or without an engine warning light, one of the checks that must be included in the diagnosis path is to remove the air intake pipes from the Turbocharger Inlet and inspect inside.

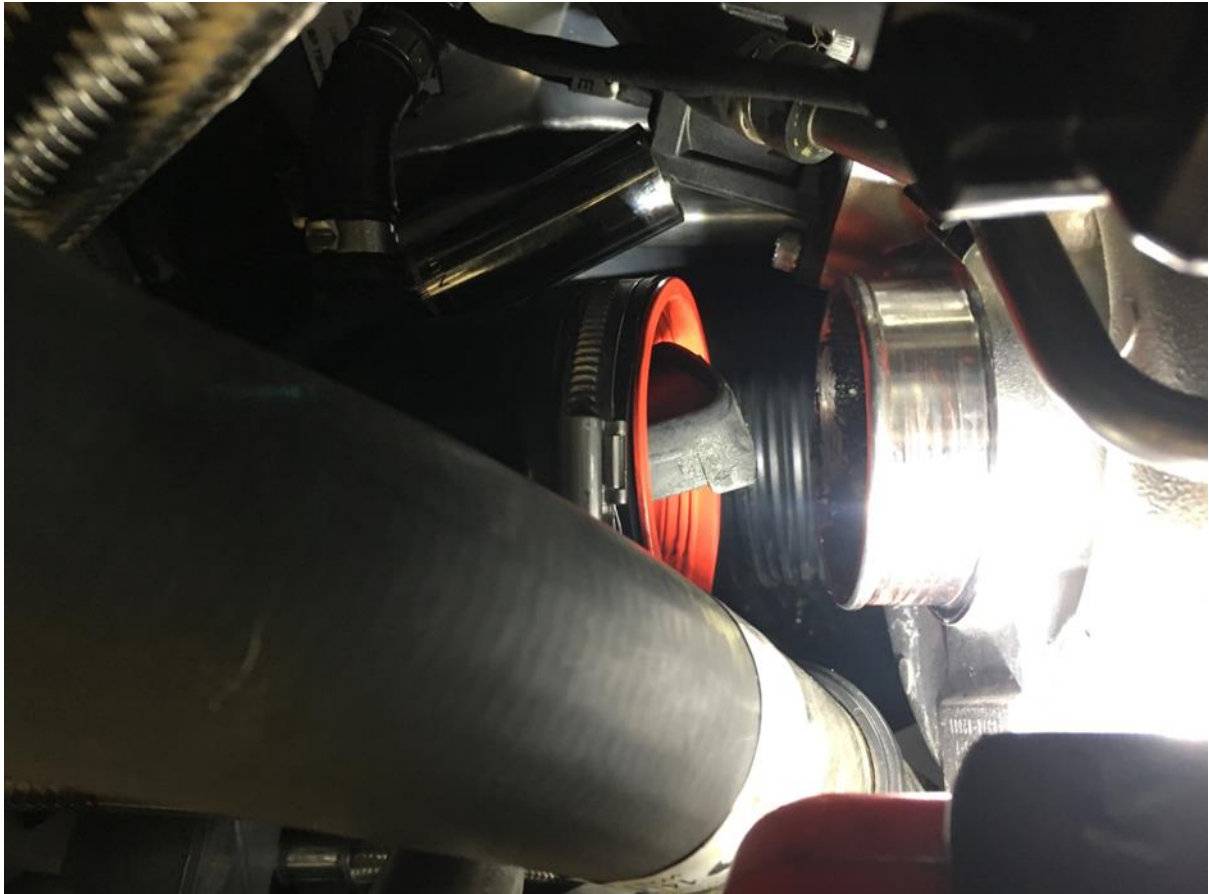
It has been reported that an internal plastic baffle cover can be found loose inside the Turbocharger Air Intake pipework blocking the air flow to the Turbocharger.

This can also result in contact with the Turbocharger Compressor Wheel causing damage.

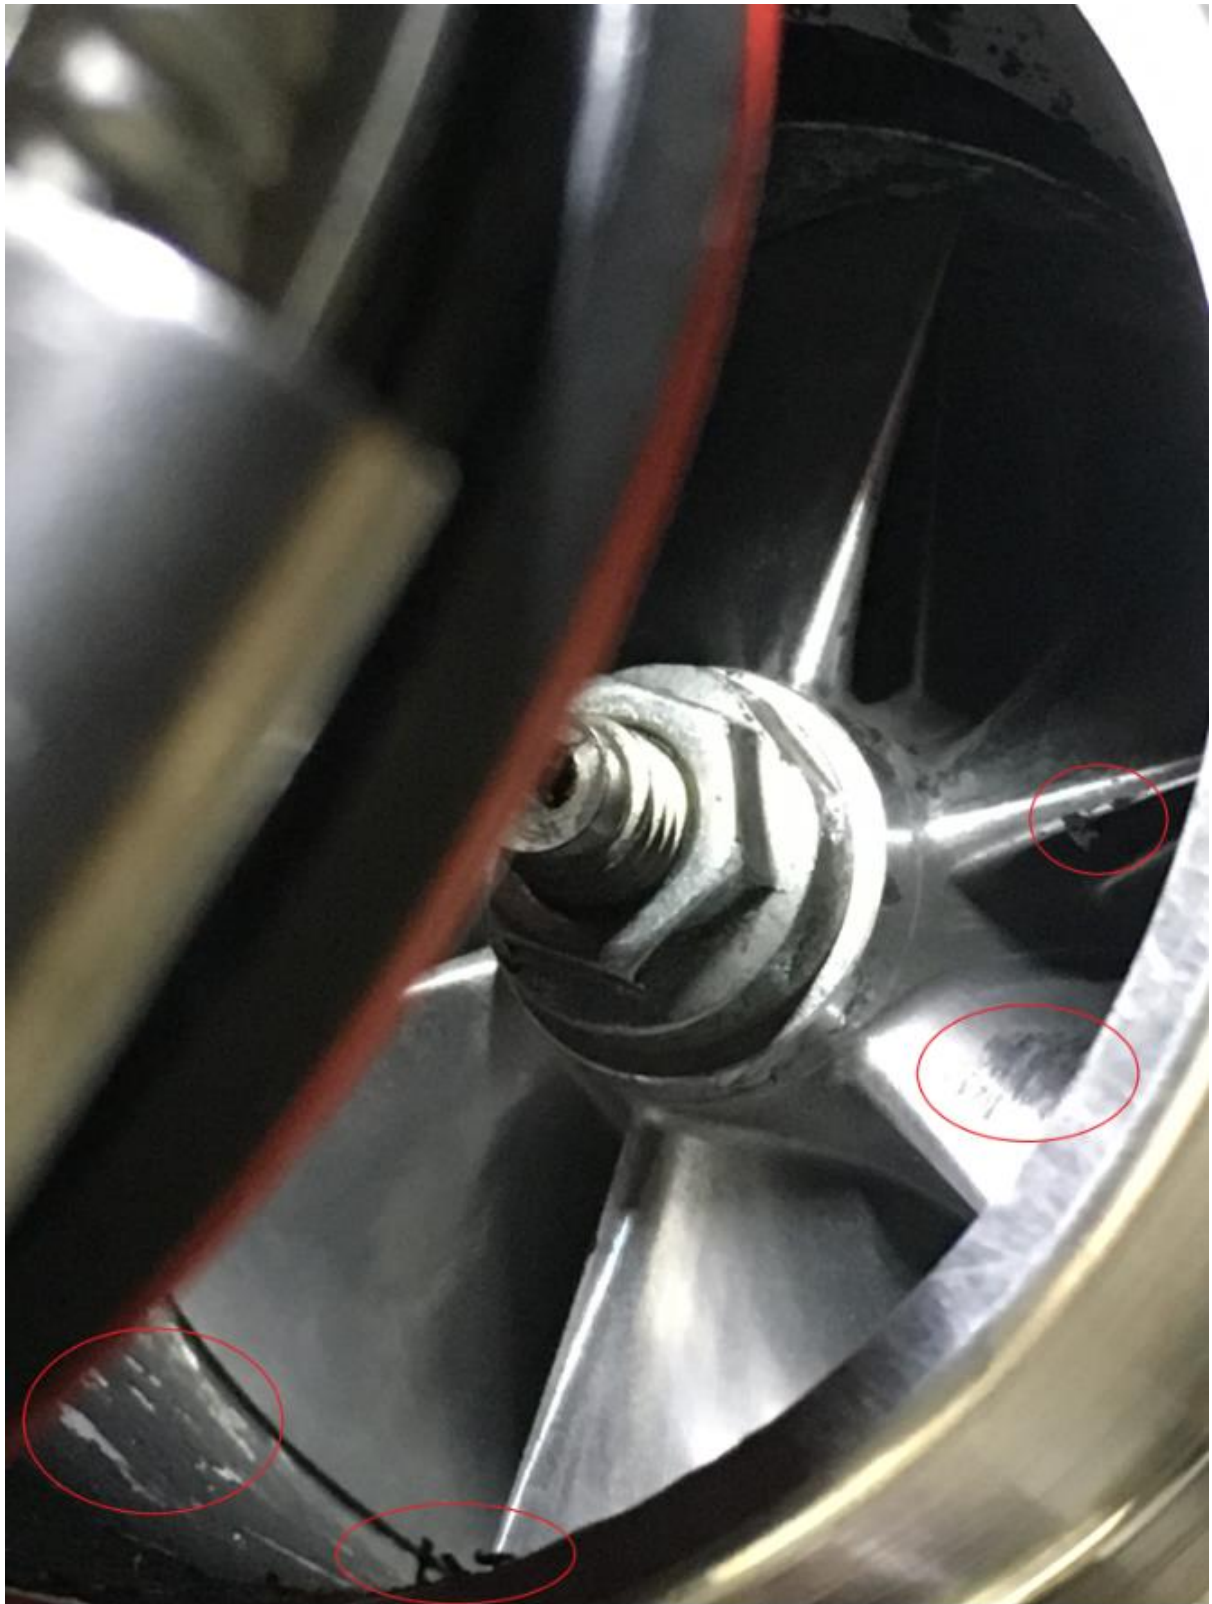
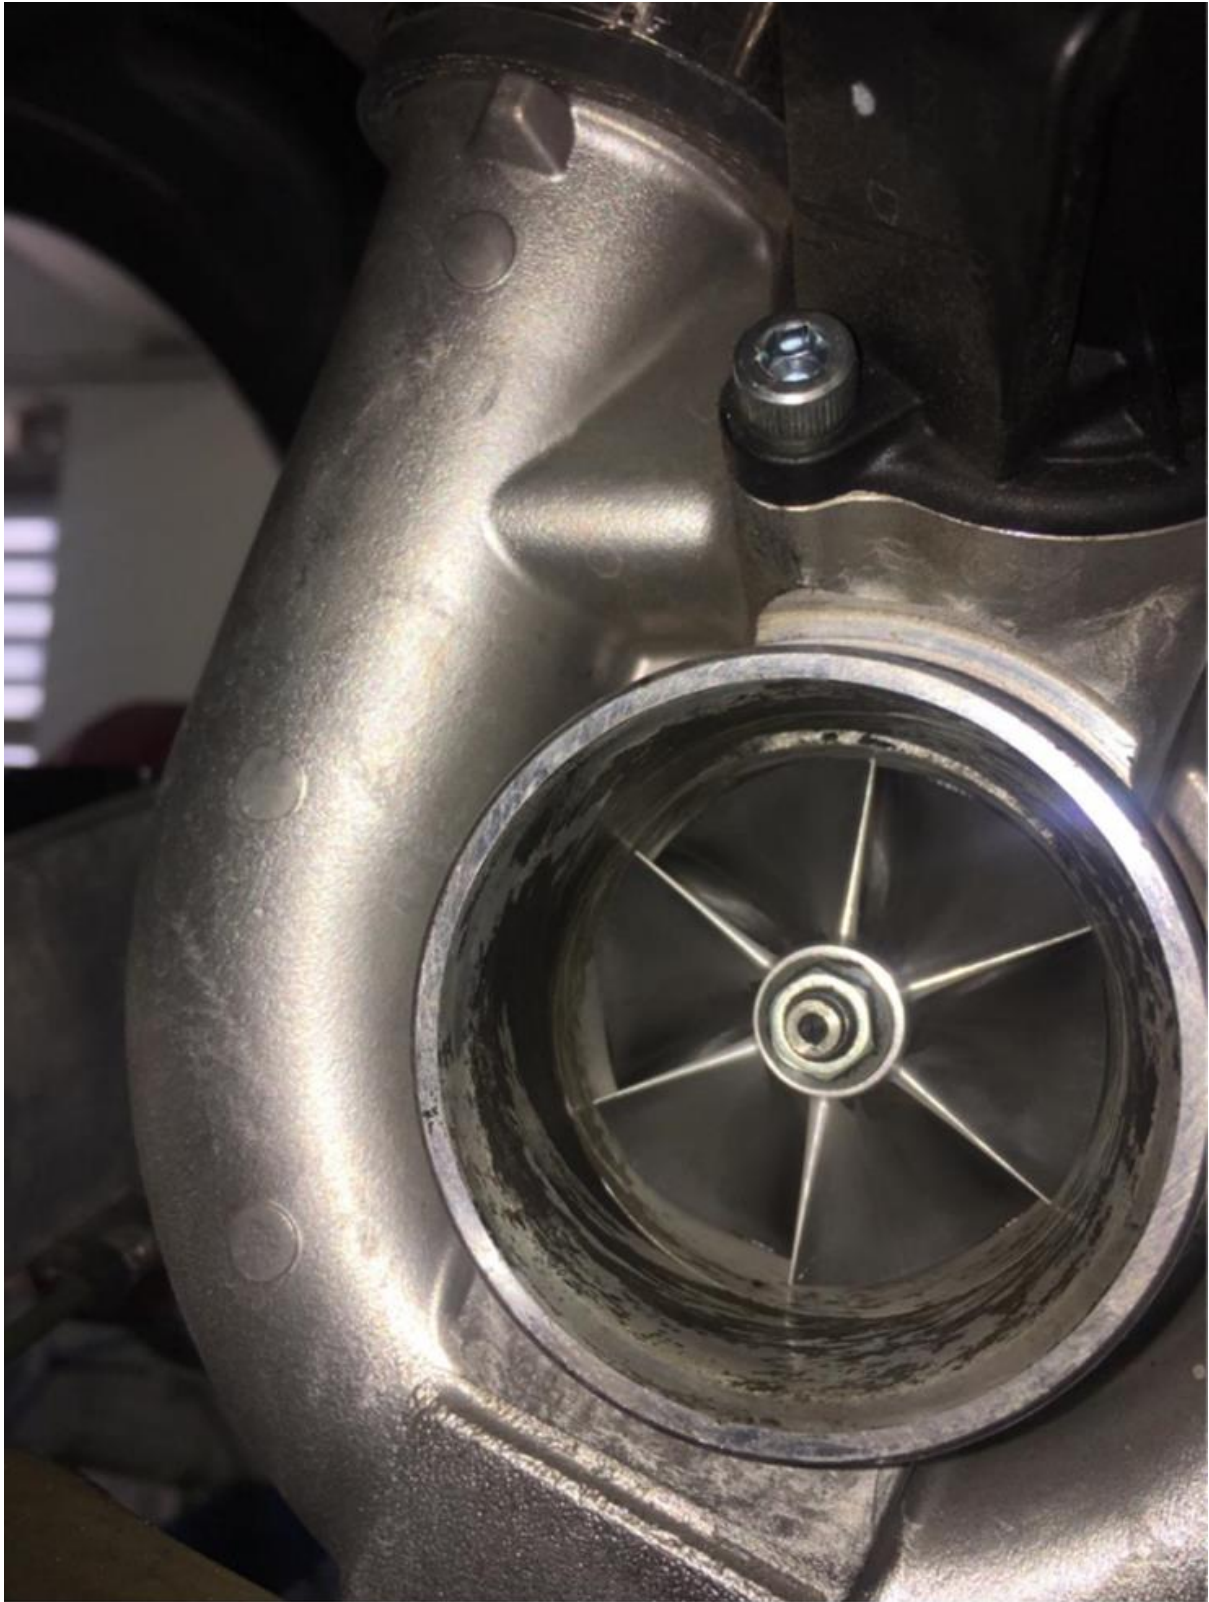
If this condition is found, inspect the Turbocharger Inlet and Compressor Wheel for visible black marks from the plastic baffle cover.

If there are marking evidence, this means that the plastic baffle has made contact with the Turbocharger Compressor Wheel. Due to the light weight and soft material of the plastic baffle cover it is not necessary that Turbocharge damage has occurred.

1. Inspect the Turbocharger Compressor Wheel fins for visible defects
2. Inspect the Turbocharger Compressor Wheel housing for contact with the Compressor fins
3. Inspect the Turbocharger shaft for excessive axial or radial play
4. Inspect the Intercooler for signs of debris

If damage to the Turbocharger can be seen, raise a Technical Request and supply all the necessary information for further investigation.

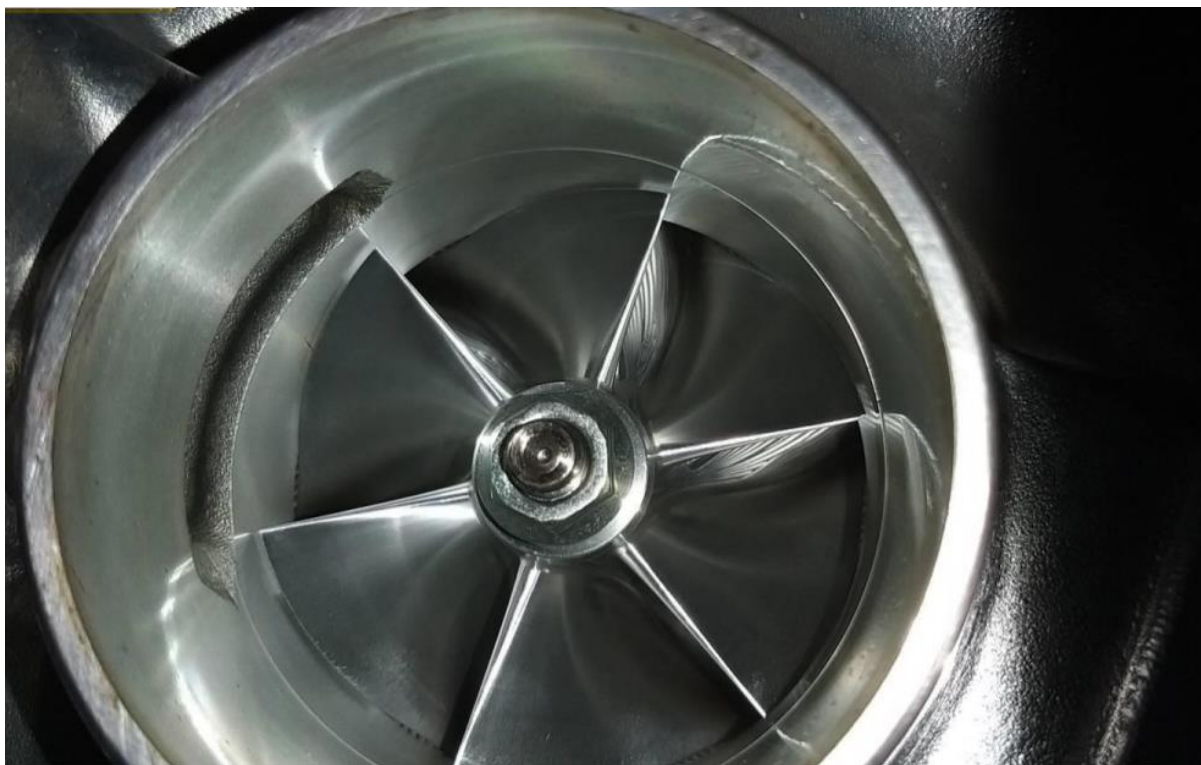
If no damage to the Turbocharger can be identified (picture below) then proceed with replacing the pipework only - see Parts Information section for part numbers.

14F0846CP - HOSE - CLEAN AIR DUCT - RH

14F0845CP - HOSE - CLEAN AIR DUCT - LH

14F0202CP - SEAL - CLEAN AIR DUCT

00RB030 - HOSE CLAMP - 60-80 - NORMA TORRO
