Body BIW – Active Aero – P14: 720S, 720S Spider – Follow the instructions available in this article to install an external catch tank in the event of a customer complaint for persistent issues with the airbrake system even though MTI0017 has been completed on a previous visit

P14: 720S, 720S Spider

Location: Body BIW – Active Aero

Concern: Airbrake Warning Message On Driver's Display

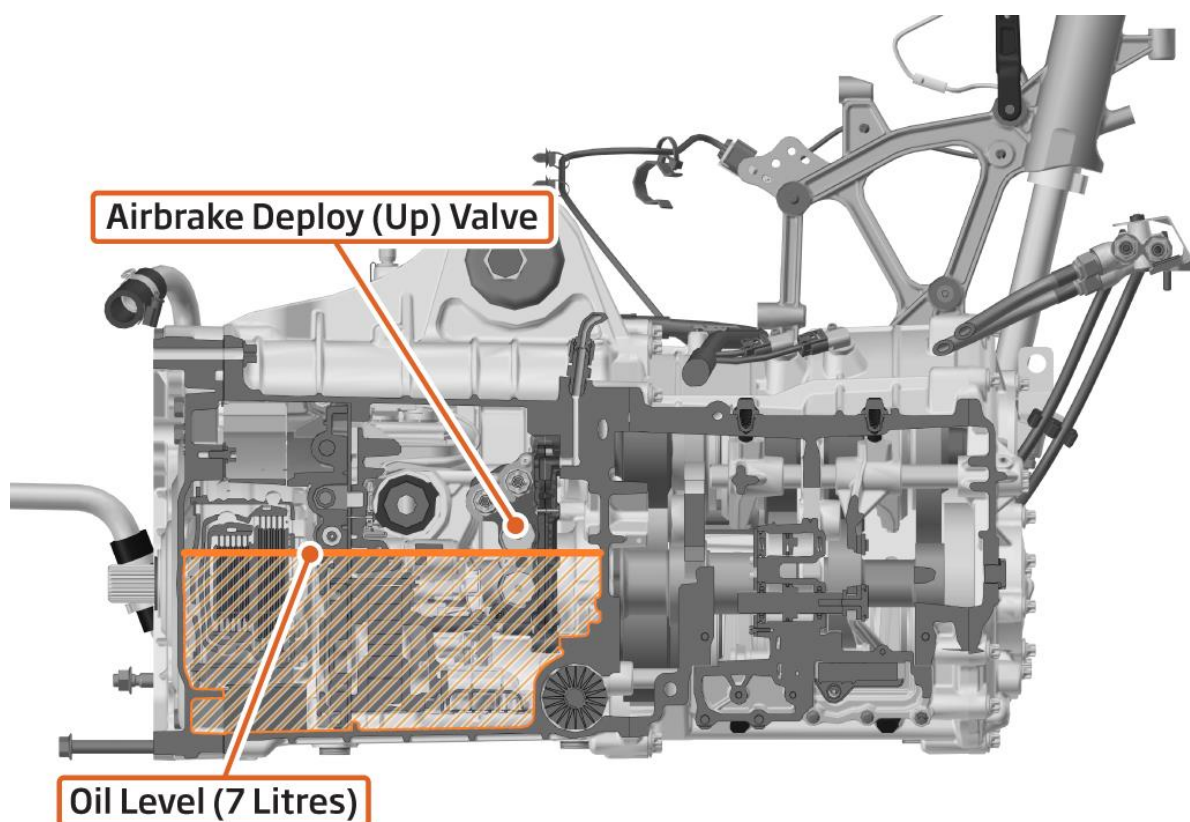
The level of the clutch fluid when is not being pumped around the transmission can sit lower than the airbrake deploy valve (see image below) within the transmission.

When the engine is running so is the oil pump in the transmission, which will distribute the oil covering the deploy valve stopping the risk of introducing air.

However, there can be various driving and airbrake deployment conditions that could still allow the system to pull through clutch fluid and air. The presence of air in this hydraulic system can result in reduced functionality of the airbrake followed by airbrake warnings and DTCs being registered as outlined in the 'Diagnostic Trouble Codes' section above.

In order to eliminate the possibility of this occurring, it is advisable to retrofit an external clutch fluid catch tank. Ultimately, this will allow for an increase in the clutch fluid fill which will result in a higher clutch fluid level in the transmission without causing leaks from the breather valve.
