Body BIW – Active Aero – P14: 720S, 720S Spider, 765LT – Follow the instructions available in this article to install an external catch tank in the event of a customer complaint for persistent issues with the airbrake system even though KA-01105 has been completed on a previous visit

Location: Body BIW – Active Aero

Topic: Airbrake Warning Message On Driver's Display

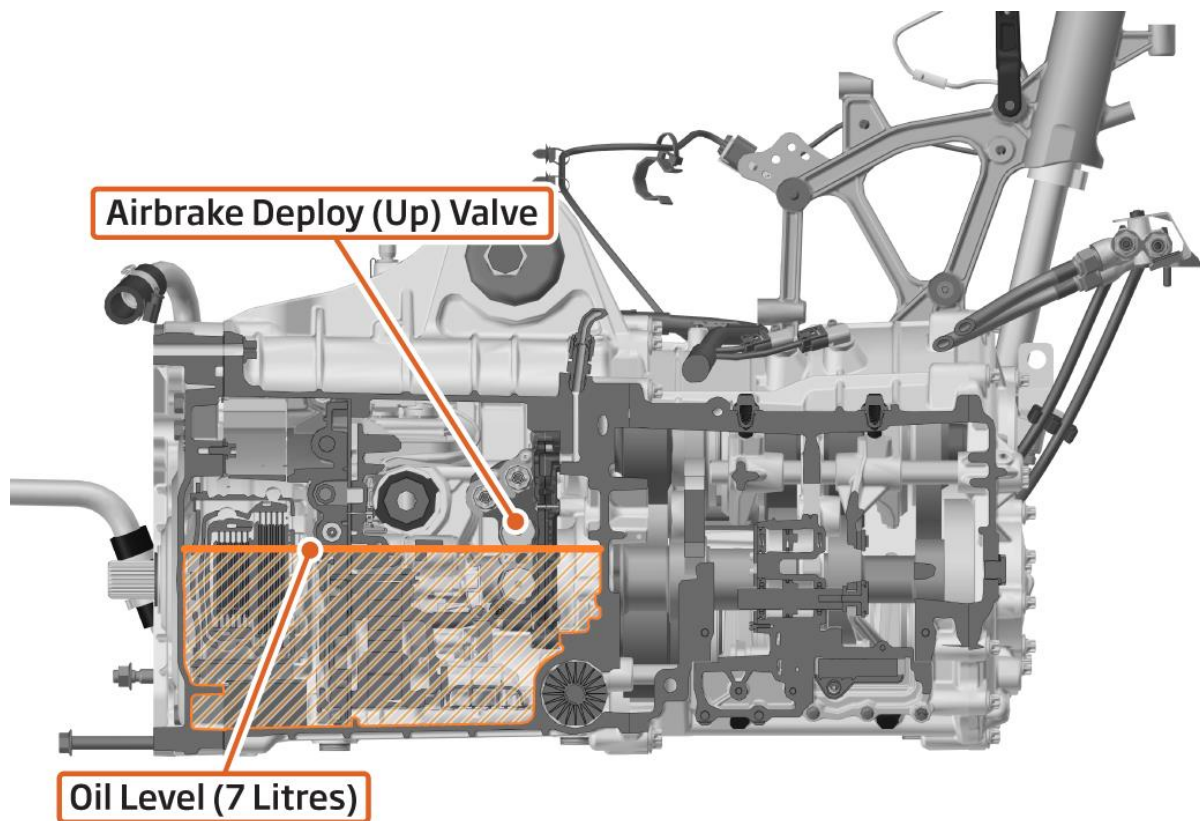
The level of the clutch fluid when is not being pumped around the transmission can sit lower than the airbrake deploy valve (see image below) within the transmission.

When the engine is running so is the oil pump in the transmission, which will distribute the oil covering the deploy valve stopping the risk of introducing air.

However, there can be various driving and airbrake deployment conditions that could still allow the system to pull through clutch fluid and air. The presence of air in this hydraulic system can result in reduced functionality of the airbrake followed by airbrake warnings and DTCs being registered as outlined in the 'Diagnostic Trouble Codes' section above.

In order to eliminate the possibility of this occurring, it is advisable to retrofit an external clutch fluid catch tank. Ultimately, this will allow for an increase in the clutch fluid fill which will result in a higher clutch fluid level in the transmission without causing leaks from the breather valve.
