**Location:** Chassis - Suspension Fluid Systems

**Topic:** Cyclic noise from the power steering pump with or without suspension warning message

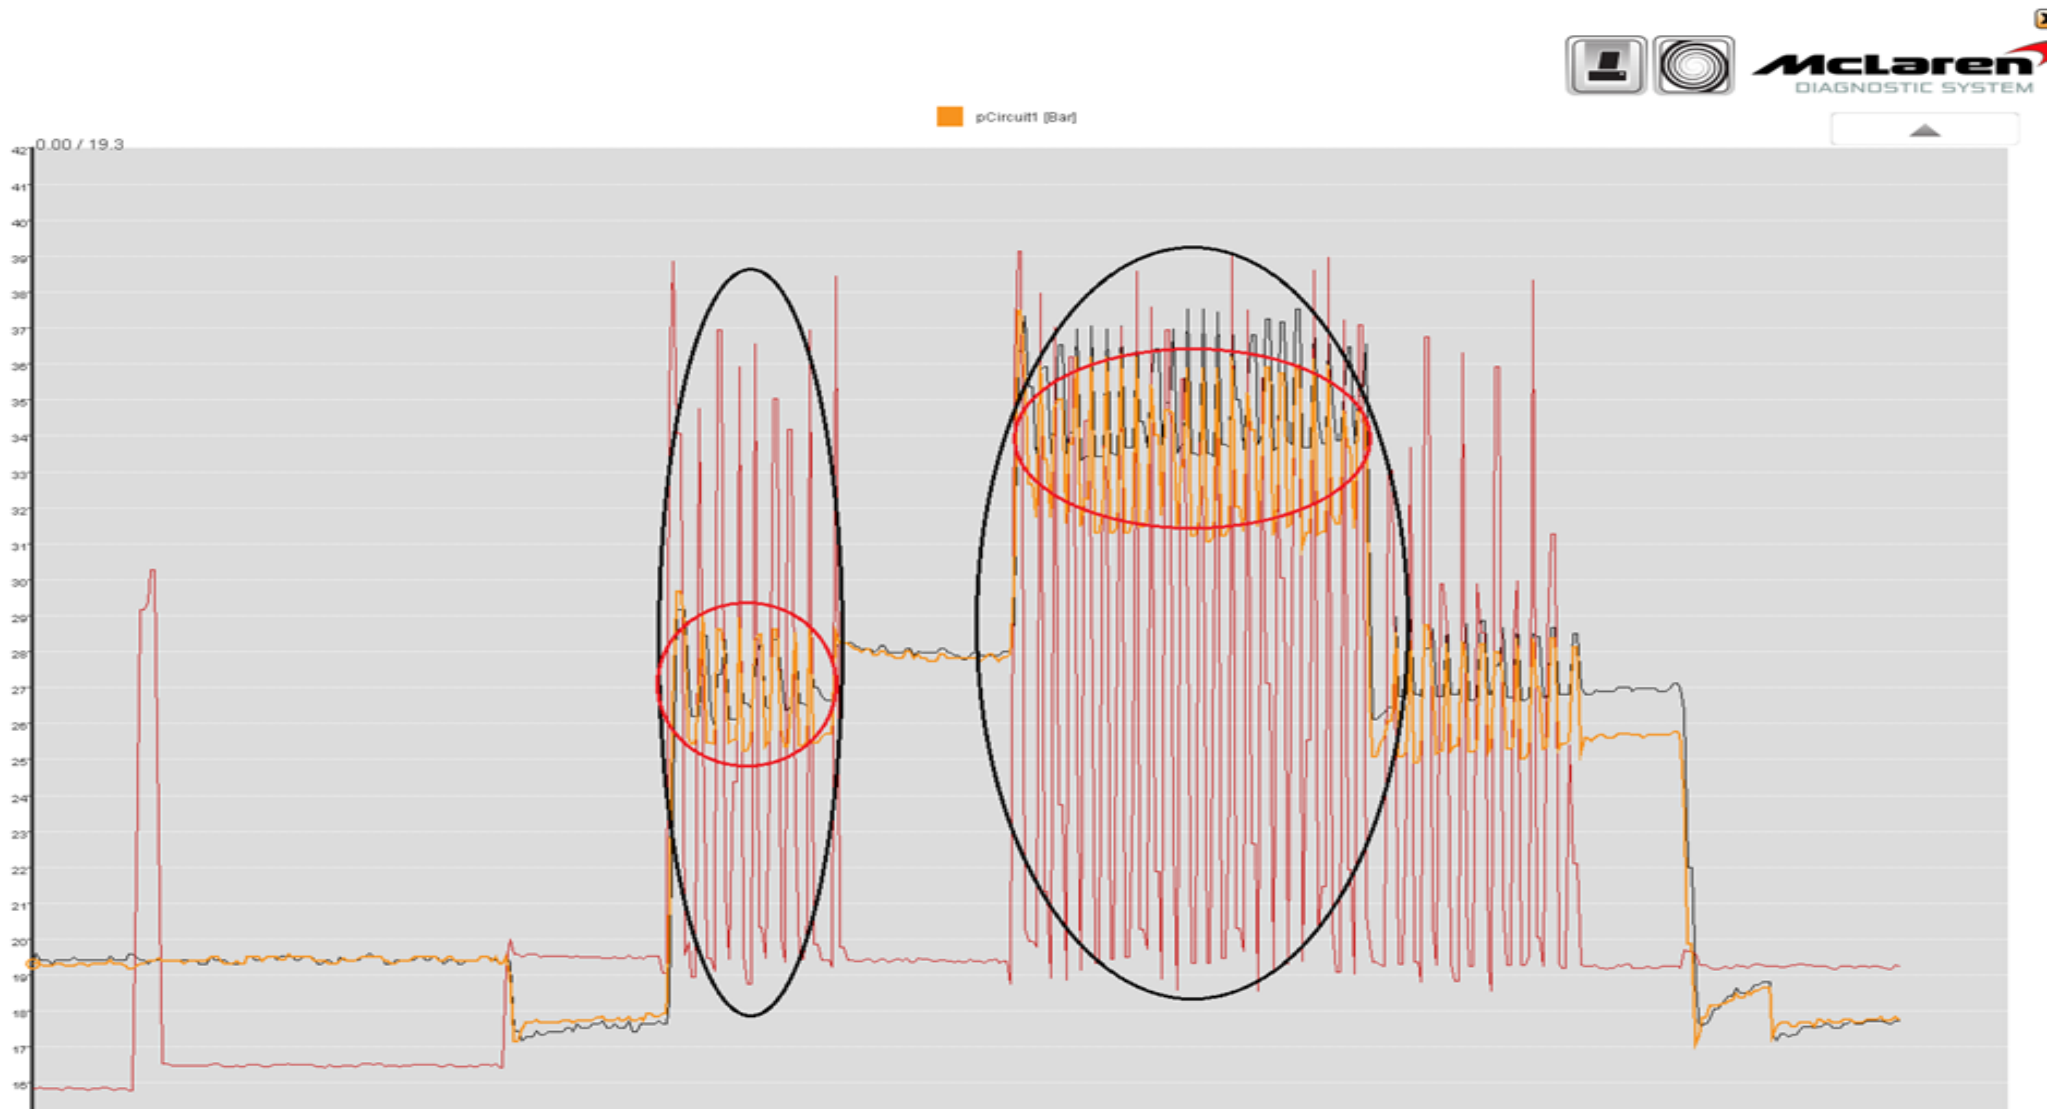
### Figure 1 - Degraded Vehicle Behaviour

In Figure 1 the circled areas indicate the pressure oscillations in the EHPAS line, pressure circuit1 and pressure circuit2. These oscillations are a result of the decreased hydraulic circuit dampening effect of the accumulator(s) caused by the loss of gas. These oscillations themselves create a pressure data feedback loop to the CCU which activates the APMU valves and keeps the pump cyclic in order to compensate and try maintaining nominal pressures.

If the resulting line graph looks like 'Figure 1 - Degraded Vehicle Behaviour' below, replace all 4 accumulators.

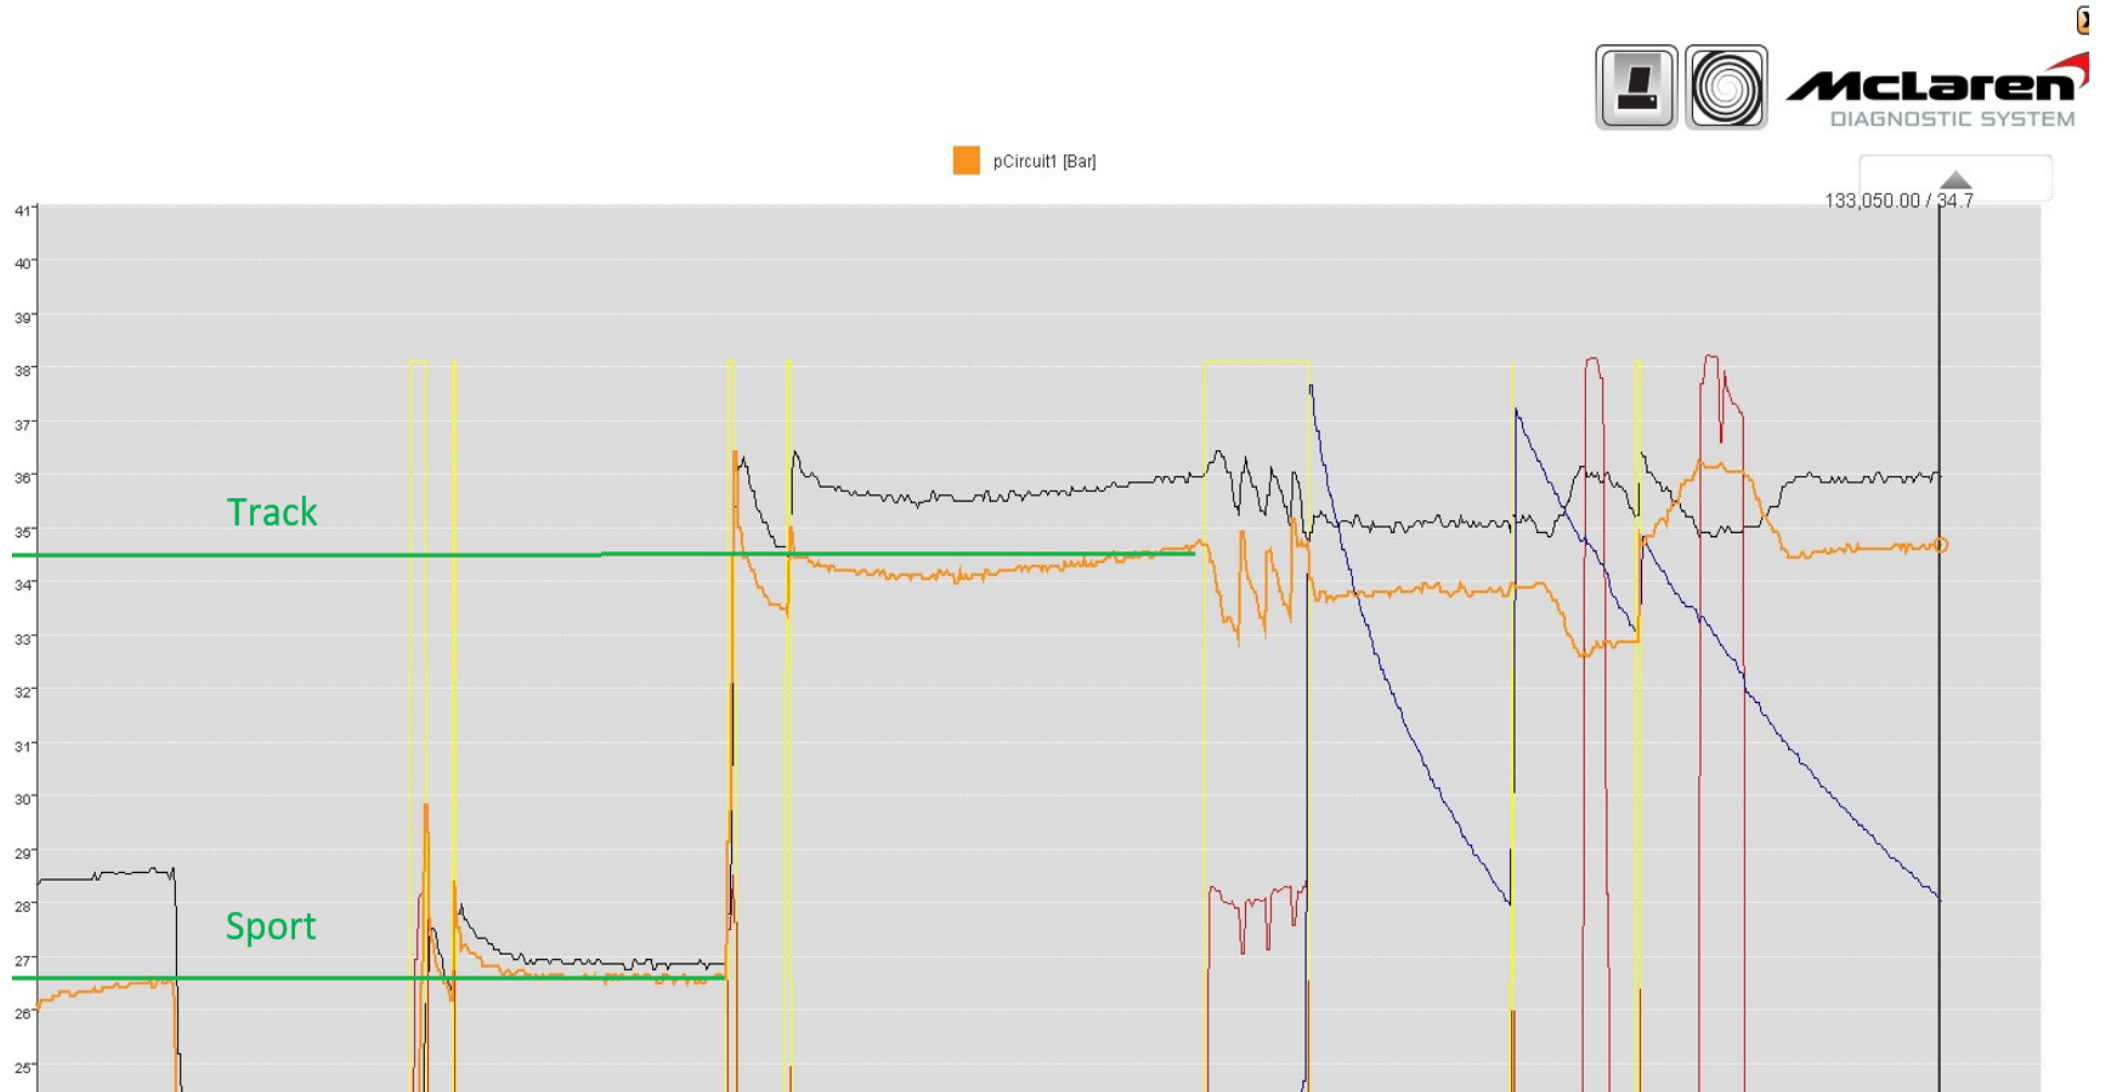
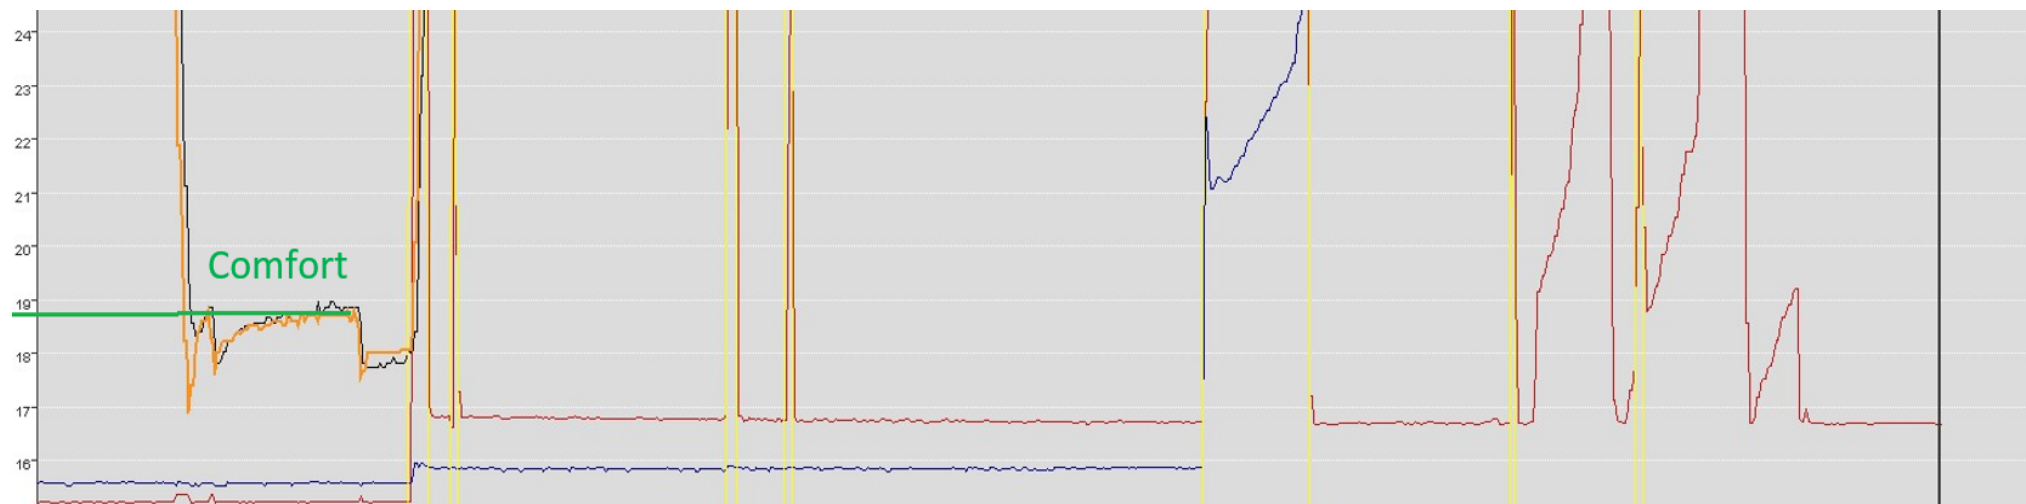
Figure 2 - Nominal Vehicle Behaviour

In Figure 2 we see a normal behaviour of the EHPAS line, pressure circuit 1 and pressure circuit 2. It is obvious that the system achieves the nominal pressure with minimum amount of oscillations as designed. The added green lines across the graph indicate the nominal pressures for each suspension mode. Starting from comfort with a stepped pressure increase to Sport and then Track mode as they are selected in succession during the Mode Change Assessment routine described above.

If the resulting line graph from the mode change assessment routine looks like Figure 2 below but you are still experiencing suspension errors, raise a Technical Request and supply all the information collected based on this document.
