Steering Noise Diagnosis Guide

Topic: Guide to diagnosing "clicking" sound when turning lock to lock statically or at low speed

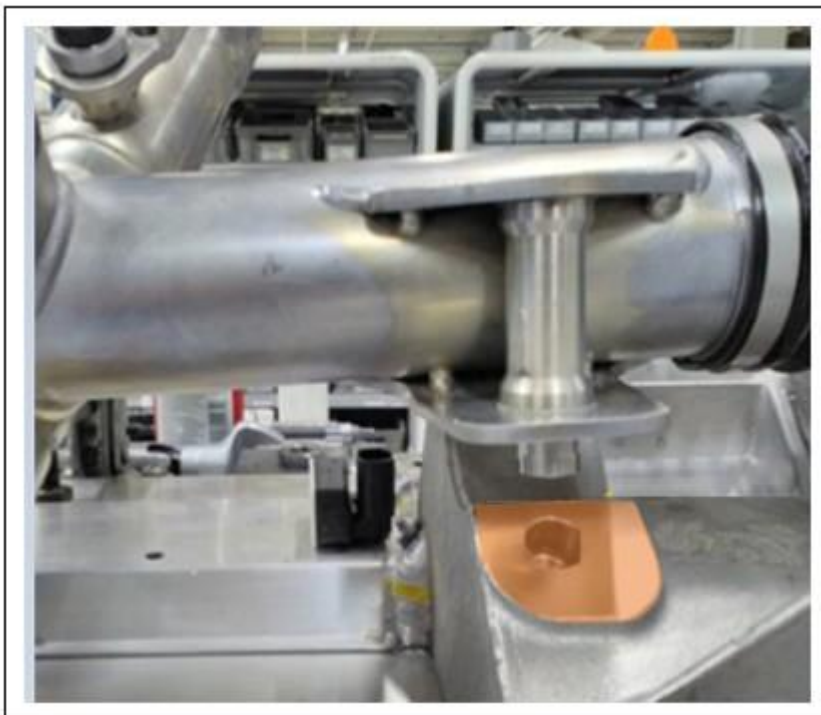
Clicking from the steering can be caused by grease or poor contact at the mounting points of the steering rack as per **Figure 1.1**. With grease or another lubricant present on the mounting faces, slight movement may be present which can produce an audible "click" or "knock" when turning.

Figure 1.1 – Area to be cleaned

It is necessary to gain access to the mounting faces and clean both the subframe and steering rack face so it is free from grease or any other lubricant.

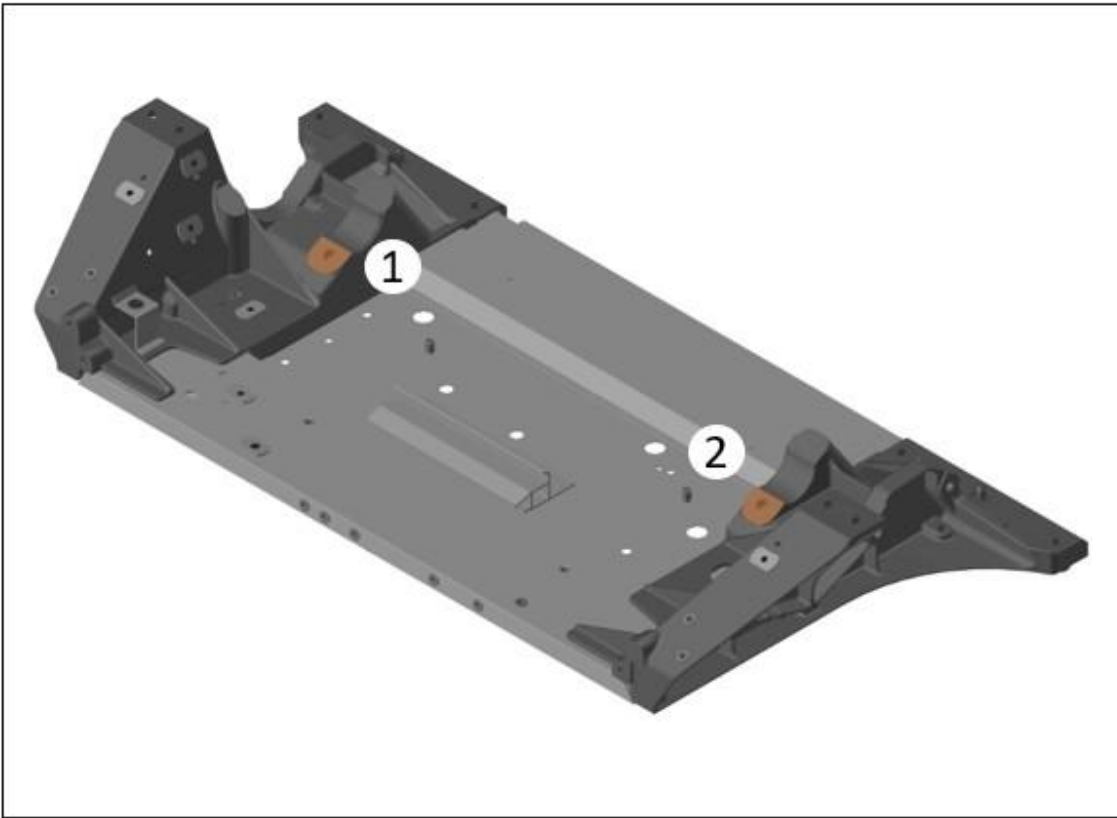
Figure 1.2 – Both areas to be inspected and cleaned

A product such as Loctite 7063 or similar is recommended to degrease the surfaces, Mounting faces to be cleaned are labelled in **Figure 1.2**.

Replace the steering rack bolts with new when refitting the steering rack.
