Topic: WCAC Inlet to Top Hose Clash

Condition: In some cases, the WCAC inlet can clash with the top hose on 720S, 765LT and/or GT.

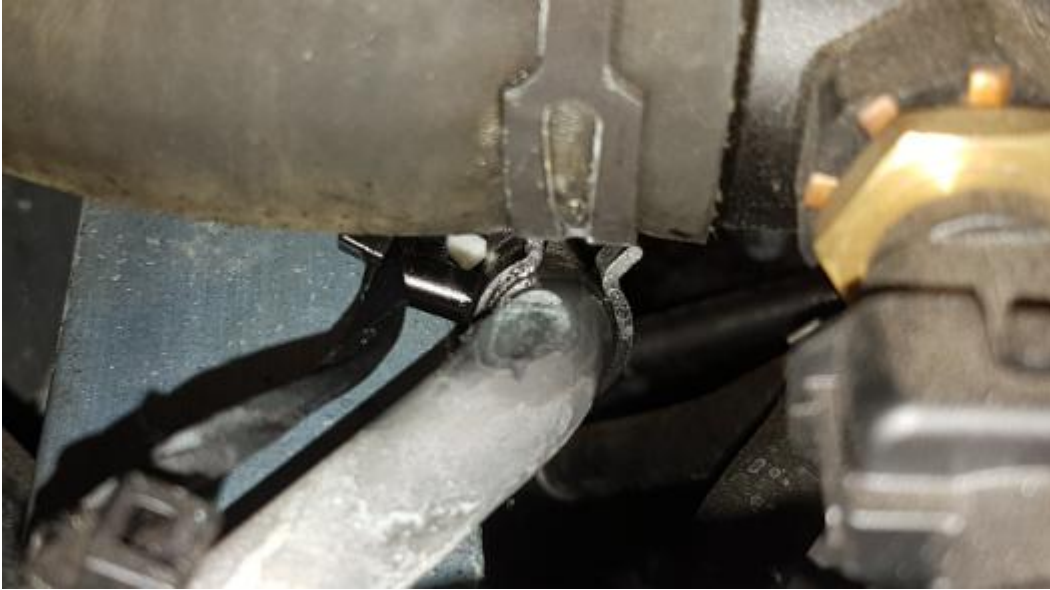
If the clash is of concern as per the image below, please raise a technical request (TR).
