KA-01937 Boost Control Diagnosis Guide

Location: Powertrain - Engine

Topic: Engine warning & loss of power under load

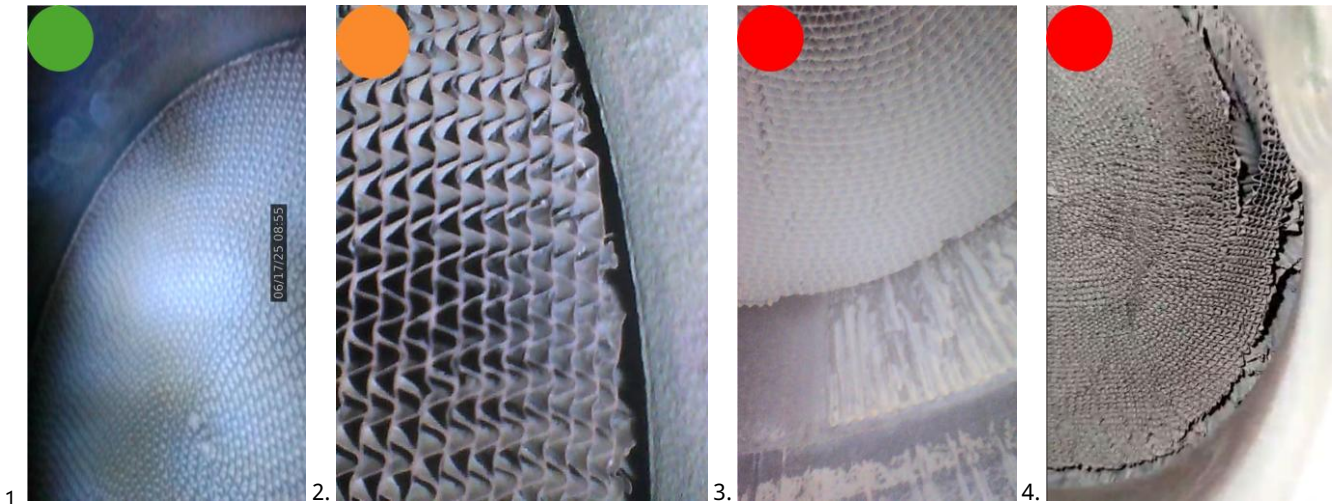
1. Smoke & air path pressure test (If possible, recommend filling system with smoke test, then pressure test to make it easier to identify any leak areas)
 - If any leak found, rectify and retest vehicle
2. Check catalyst bricks
 - Document images of catalyst internal structure and continue with next steps
 - If severely damaged, then replace before further running of the vehicle
 - Examples below show a good condition catalyst (1), partially cracked - ok for use in further testing only (2), separated
 - replace before any further running (3), cracked and separated - replace before any further running (4)

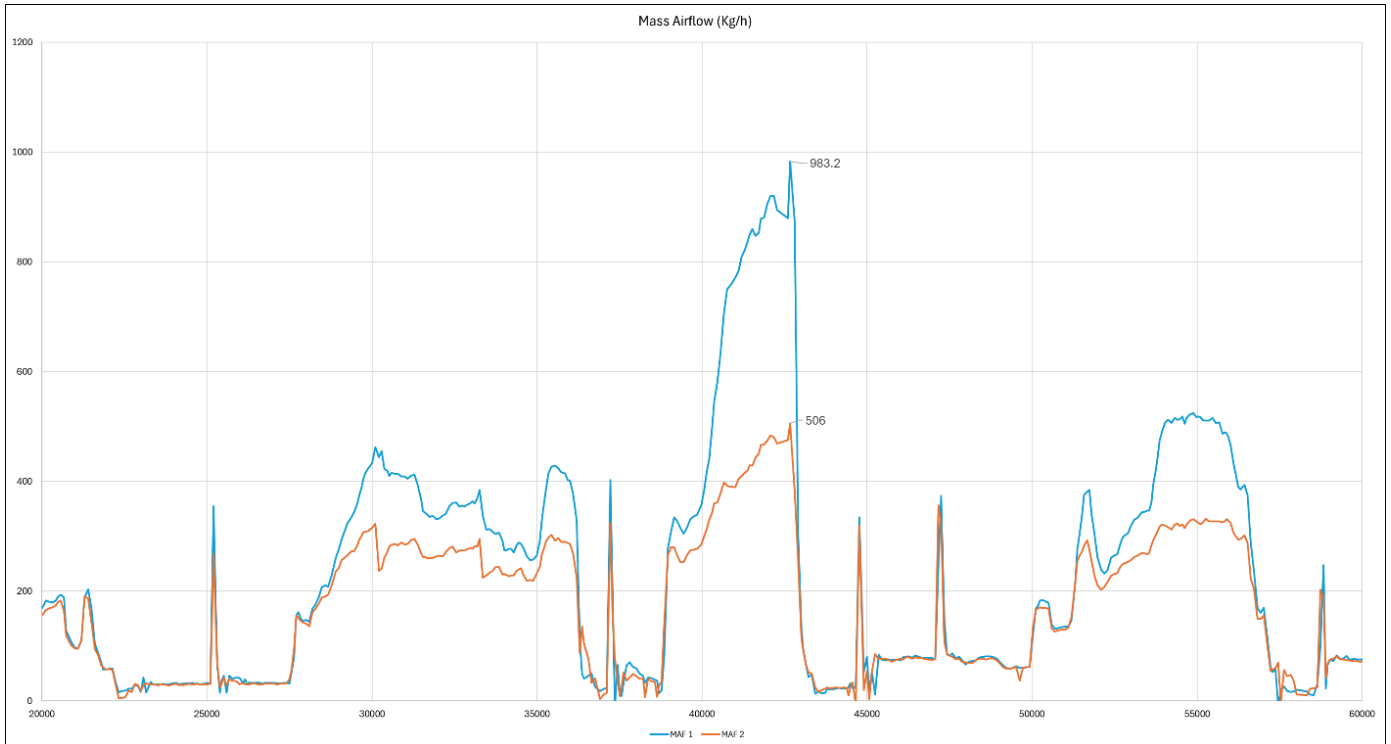
The below example graph shows large imbalance of mass airflow. The boost control DTC will trigger when vehicle detects sustained period of MAF imbalance over 150 Kg/h.

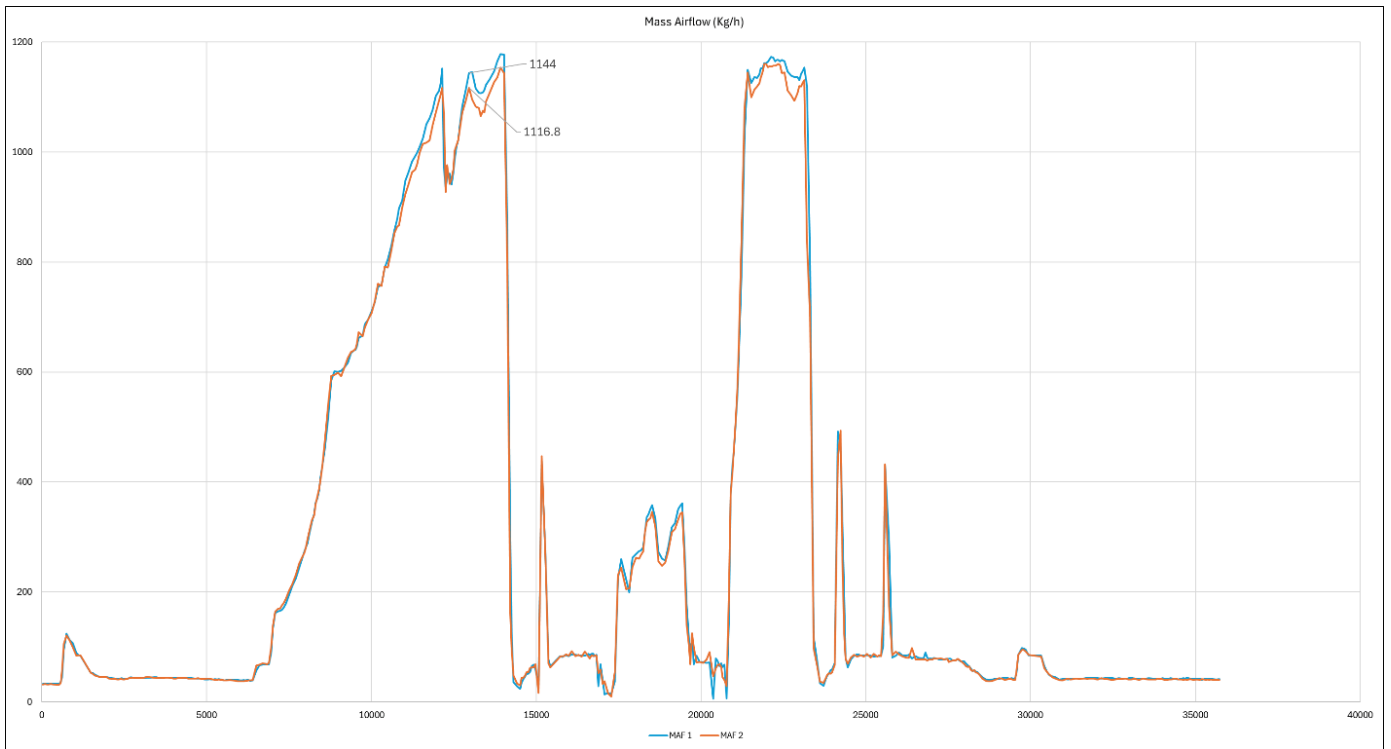
The below example shows good balance of mass airflow.
