Location: Powertrain / Engine

Topic: V8 Coolant Hose Drift

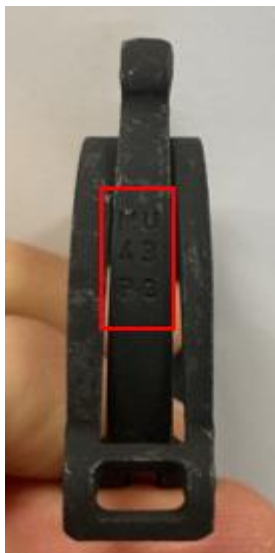
Coolant hose end to water pump spigot shoulder only serves as an assembly aid to position the hose correctly on the spigot length to ensure the spring band sits behind the spigot barb upon installation.

Care point: Correct clamp used (Marking: MU 43 P3), and clamp should be positioned behind the clamp marking.

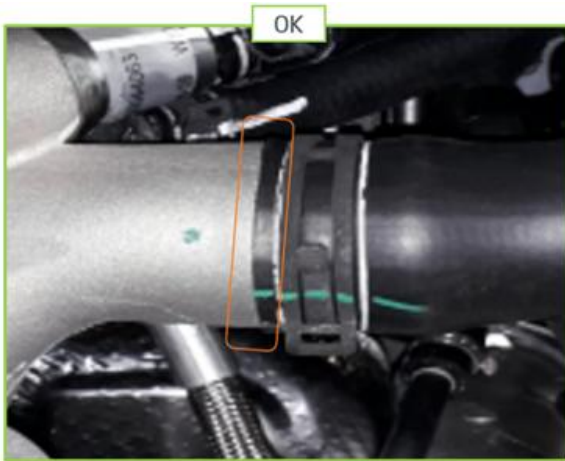
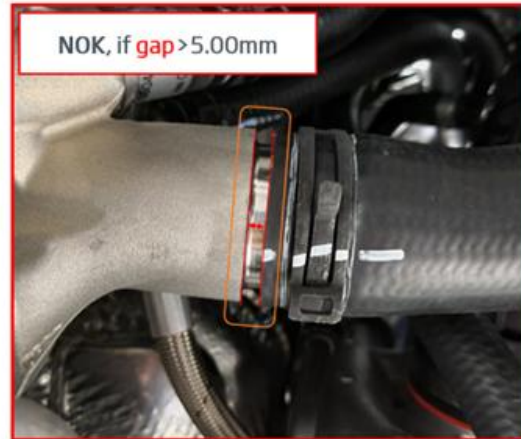
It has been identified that on V8 engines, the lower coolant hose can move away from the spigot shoulder on the water pump, this happens due to pressure testing and when vacuum filling the cooling system.

Should there be a gap as shown in the image below, please measure the gap and ensure it is under 5mm.

There is no physical problem with the hose sliding up against the spigot barb under coolant pressure.

If a gap over 5mm is identified, allow engine to cool and release the coolant expansion bottle cap to release any residual pressure in the cooling system.

Compress the clamp and reposition the coolant hose according to the image below labelled ok and top up any coolant that may have spilled.
