Rear Toe Link Inspection & Potential Replacement

Bulletin type:	Service Campaign
Reference number:	SCB 00 B 001
Attention:	Retailer Service Managers and Retailer Technicians
Affected vehicles:	McLaren 600LT (Coupe and Spider), McLaren 720S (Coupe and Spider) and McLaren Senna (excludes GTR)
Situation:	The durability of the rear toe link outer ball joint may not be within expected tolerance
Procedure:	Action affected vehicles during next Retailer visit. Please refer to the information outlined in this document to check the installed rear toe link and replace only if necessary
Date:	20th August 2020

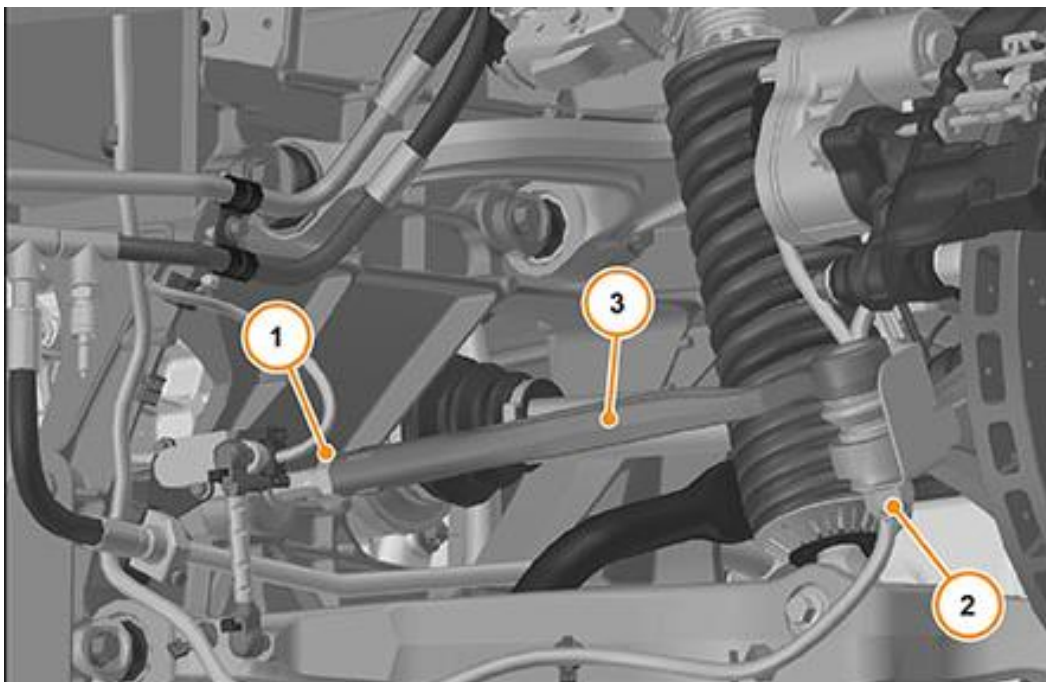
Rear toe link (3)

Through continuous product quality monitoring, it has been identified that a number of McLaren 600LT (Coupe and Spider), McLaren 720S (Coupe and Spider) and McLaren Senna (excludes GTR) vehicles may have a rear toe link outer ball joint which is not within expected tolerance. Therefore, inspection of the part and potential replacement of the complete rear toe link may be required.

(1 - Adjustment nut, 2 - Nut. Example taken from Service Information System (SIS) for McLaren 720S Coupe)

- a. Secure/Lift vehicle on platform
- b. Inspect the rear toe link(s) for the batch code (refer to Section 4 'Warranty Information' for location of the batch code on the part)
 - I. If the batch code matches one of the following listed, the rear toe link(s) must be replaced. Refer to the Service Information System (SIS) for the appropriate repair procedure.
 - FLH
 - FZB
 - GVB
 - GKK
 - HAF
 - HCH
 - II. If the batch code does not match one listed, no further action is required.
- c. End procedure

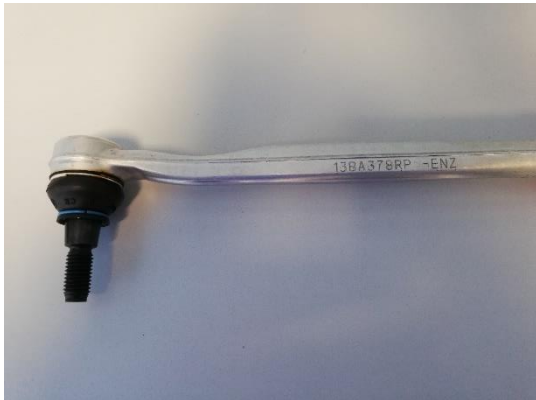
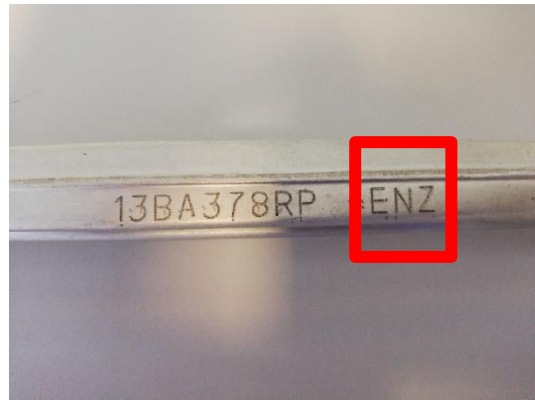
Example:

Please ensure when claiming for a replacement of a rear toe link(s), you include a photograph of the concerned batch code which can be found stamped on the part, as shown in the example below. Failure to do so will result in a rejection of the claim.
