Service Campaign Bulletin

Torque Checks and Pipe Protection Sleeve Installation

Document Number	14 A 001
Campaign Reference	04E
Affected Vehicles	720S
Date Released	21 st June 2017
Version	1

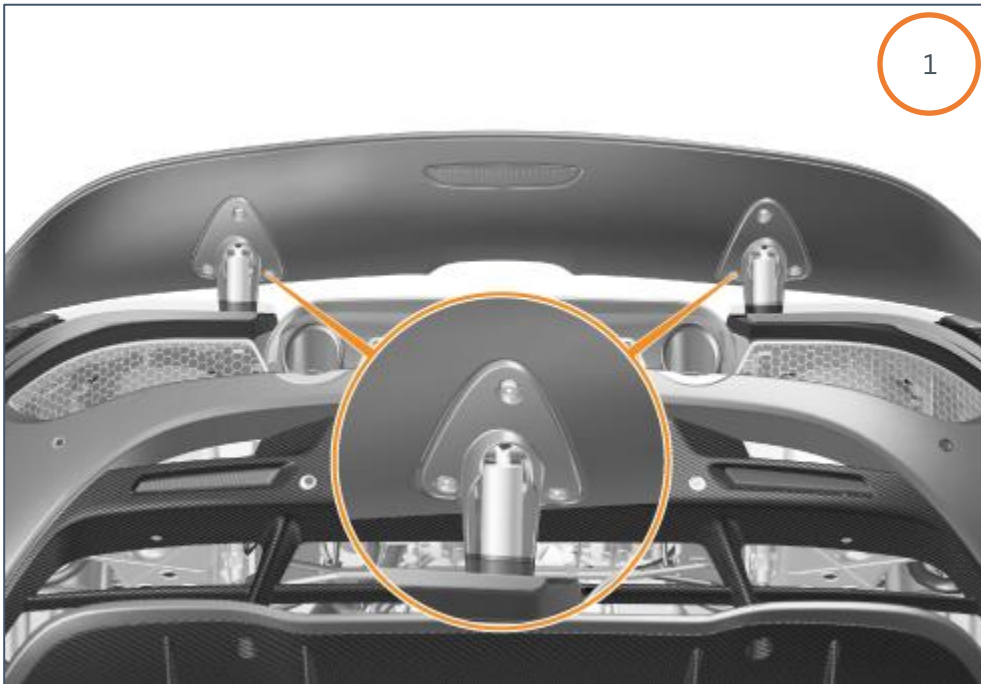
Airbrake Panel Instructions

McLaren Automotive have identified a number of 720S vehicles released from production with potentially incorrect torque of the airbrake panel mounting bolts and both rear damper top fixings. As a result, Retailers are required to check the torque of these components. In addition, a clash condition between the starter harness and the oil feed pipe has been identified therefore a rubber pipe protector is required to stop potential noise.

1. Turn the ignition ON.
2. Press the ACTIVE button to switch on the active dynamics panel.
3. Press the AERO button to raise the airbrake panel.
4. Check the torque (14Nm) of the airbrake panel mounting bolts M6 x 18 (1). If one or more are found loose, retorque to the correct value 14Nm.
