Front Brake Pad Wear Sensor Harness Re-routing

Bulletin type: Service Campaign Bulletin
Reference number: 14 C 001
Campaign reference: 041
Attention: Service Managers and Retailer Technicians
Affected vehicles: 720S
Situation: Front brake pad wear sensor harness routed incorrectly.
Procedure: Please refer to the instructions outlined in this document to complete the below checks/rework.
Date: 7th November 2017

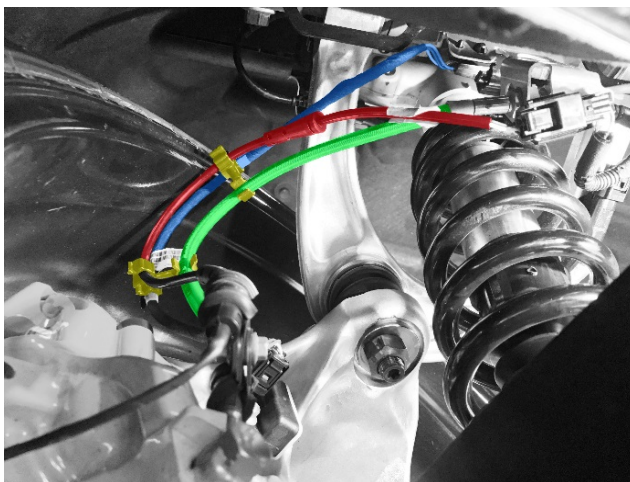
McLaren Automotive has identified that the front brake pad wear sensor harness may be routed incorrectly on some vehicles. This causes it to come into contact with the wheel when the steering wheel is turned on full lock.

Example of the front brake pad wear sensor harness routed incorrectly

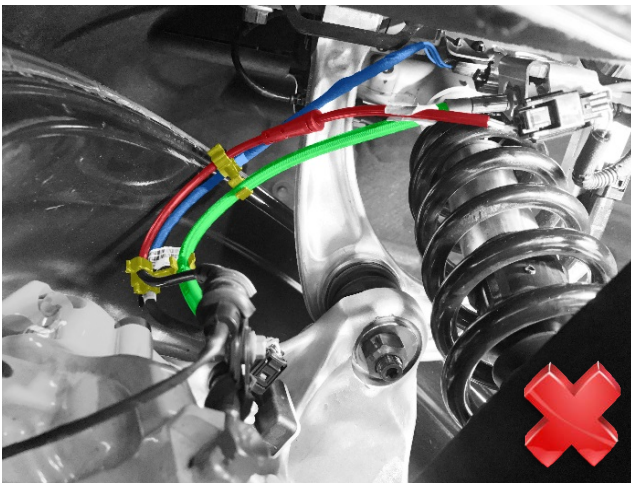
Incorrect routing: The brake pad wear sensor harness and clip are routed incorrectly, as they are above the brake pipe (shown in green).

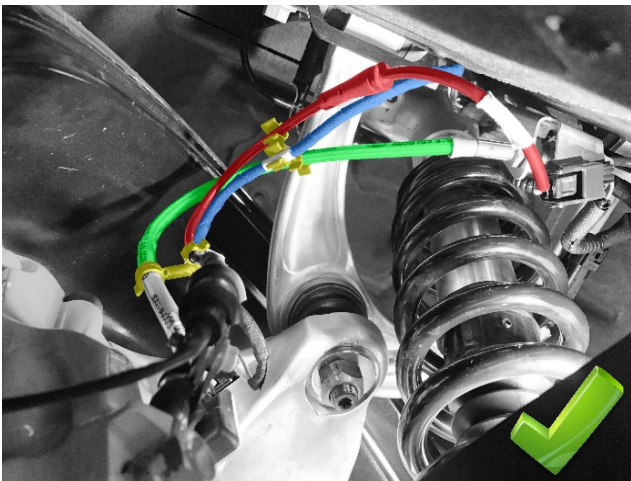
Correct routing: The brake pad wear sensor harness and clip are routed correctly, as they are below the brake pipe (shown in green).
