Software Update & Rework Requirements

Bulletin Type:	Service Campaign Bulletin
Reference Number:	14 F 001
Campaign Reference:	04F
Attention:	Service Managers and Retailer Technicians
Affected Vehicles:	720S
Situation:	Service Campaign bulletin to address a number of concerns identified after vehicles left production.
Procedure:	Please refer to the instructions outlined in this document to complete the below checks/rework.
Date:	29 th August 2017

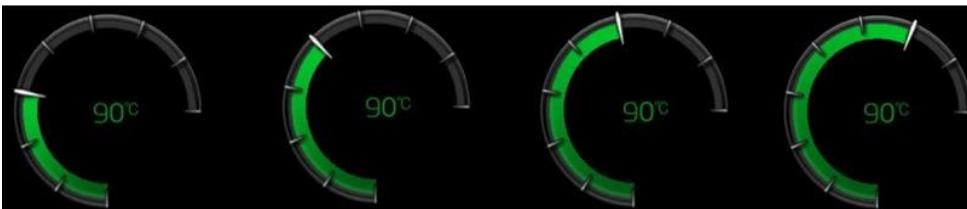
McLaren Automotive has identified that some vehicles may have left the factory with the engine oil level higher than normal, this may lead to severe engine damage if left unchecked.

The engine oil level is correct when the Driver Display displays between 3 and 6 green segments (as shown below).

If the engine oil level check result is outside of the specified parameters, adjust the engine oil level as required.

The chart below provides the quantity of oil required based on the number of segments displayed.

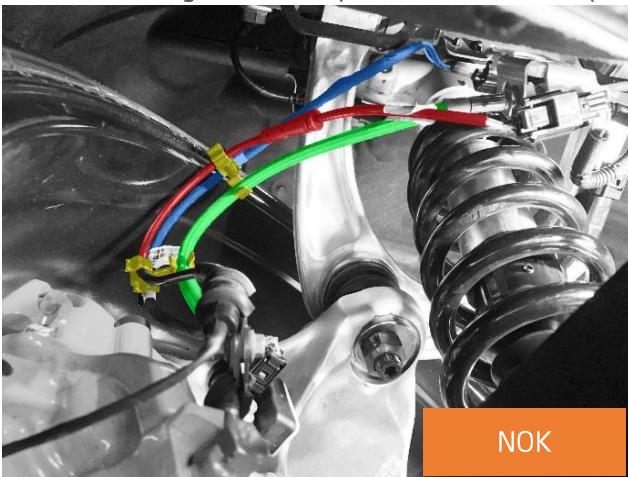
McLaren Automotive has identified that some vehicles may have the front brake pad wear sensor cable routed incorrectly, causing it to come into contact with the wheel when the steering wheel is turned on full lock.

NOK - The brake pad wear sensor cable and clip are routed incorrectly, as they are above the brake pipe (shown in green).

Disconnect the accelerometer sensor connector (1) and the brake pad wear sensor connector (2).

Ensure that both brake pipe clips (highlighted in yellow) are facing downwards. Re-fit the brake pad wear sensor and accelerometer cables onto the clips, routing them so that they are below the brake pipe and away from the wheel.

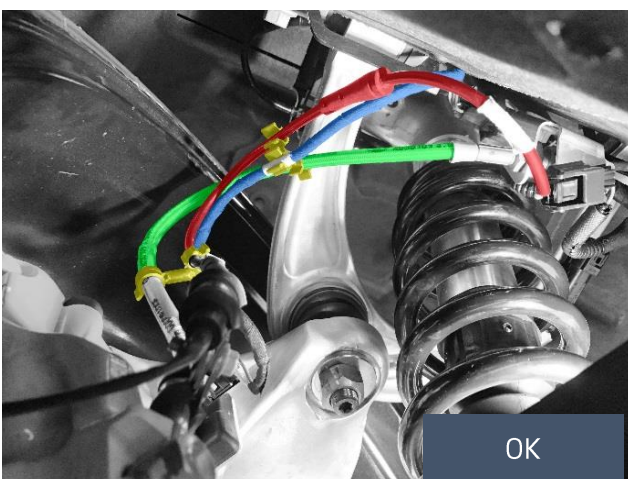
OK - The brake pad wear sensor cable and clip are routed correctly, as they are below the brake pipe.

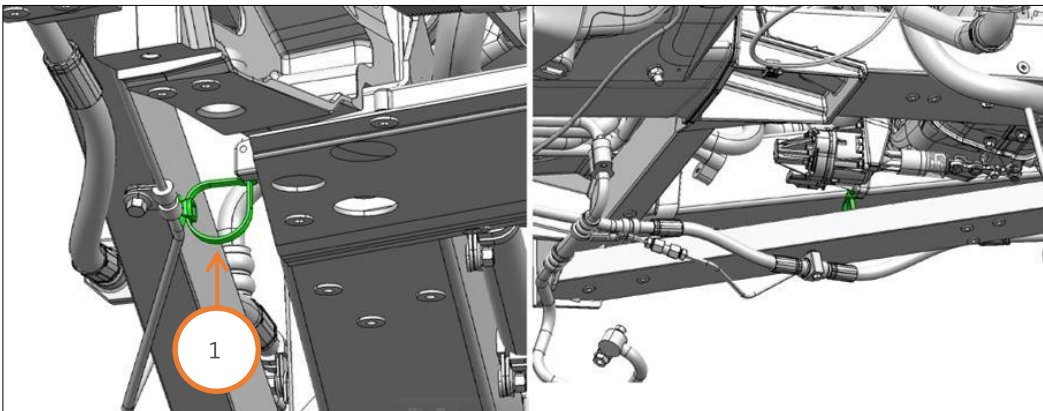
McLaren Automotive has identified that the firtree cable tie which secures the low-pressure air conditioning pipe was not fitted. If left unchecked a clash with the coolant hose may occur.

Fit a new firtree cable tie 00RL001 into the respected hole in the left rear side of the frame (1).
