McLaren 720S – WCAC Hose to CCV Pipe Clash Rework

Bulletin type: Service Campaign Bulletin
Reference number: SCB14 L 001
Campaign reference: 04U
Attention: Retailer Service Managers and Retailer Technicians
Affected vehicles: 720S; Coupe and Spider
Situation: Potential for Insufficient gap tolerance between components
Procedure: To action affected vehicles during next Retailer visit.
Please refer to the information outlined in this document to ensure sufficient gap tolerance is created between mentioned components
Date: 5th September 2019

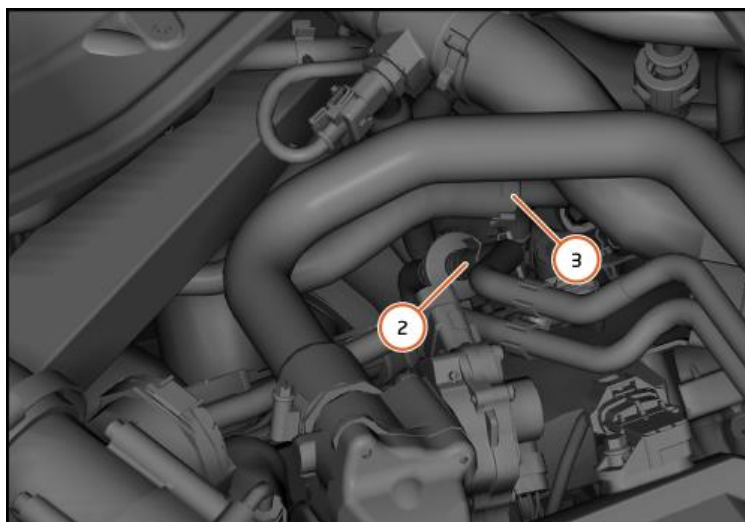
McLaren Automotive has identified through continuous product quality monitoring, that a number of McLaren 720S vehicles (Coupe and Spider versions) may have an insufficient gap tolerance between the Water Charge Air Cooler (WCAC) hose and Crankcase ventilation pipe (CCV). This could cause a clash condition and subsequent damage to the components.

Layout overview - CCV pipe (2), WCAC hose (3)

To carry out the required re-work, installation of a double 'C' clip is required which will increase the gap tolerance and prevent further potential clashes.
