# McLaren 720S – WCAC Pipe to HVAC Pipe Clash Rework

**Bulletin type:** Service Campaign Bulletin  
**Reference number:** SCB14 L 002  
**Campaign reference:** 04V  
**Attention:** Retailer Service Managers and Retailer Technicians  
**Affected vehicles:** McLaren 720S; Coupe and Spider  
**Situation:** Potential for insufficient gap tolerance between components  
**Procedure:** To action affected vehicles during next Retailer visit  
Please refer to the information outlined in this document to ensure sufficient gap tolerance is created between mentioned components  
**Date:** 5<sup>th</sup> September 2019

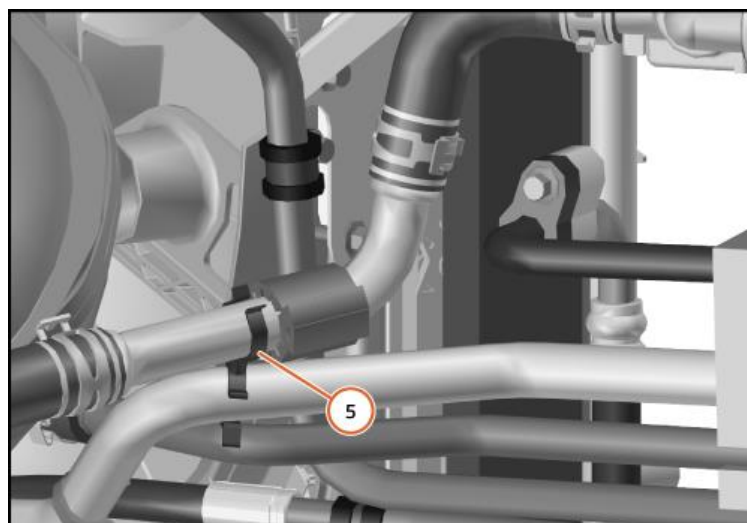
McLaren Automotive has identified through our continuous product quality monitoring, that several McLaren 720S vehicles (Coupe and Spider versions) may have an insufficient gap tolerance between a Water Charge Air Cooler (WCAC) pipe and Heating Ventilation Air Conditioning (HVAC) pipe. This could cause a clash condition and subsequent damage to the components.

Layout overview - Install clip assembly (5) and move pipe protector

To carry out the required re-work, repositioning of the existing pipe protector is required along with installation of a double 'C' clip which will increase the gap tolerance and prevent further potential clashes.
