McLaren 720S – Clutch Cooler Hose Clash Rework

Bulletin type: Service Campaign Bulletin
Reference number: SCB 14 L 003
Attention: Retailer Service Managers and Retailer Technicians
Affected vehicles: 720S Coupe and Spider
Situation: Potential for insufficient gap tolerance between components
Procedure: To action affected vehicles during next Retailer visit. Please refer to the information outlined in this document to ensure sufficient gap tolerance is created
Date: 16th January 2020

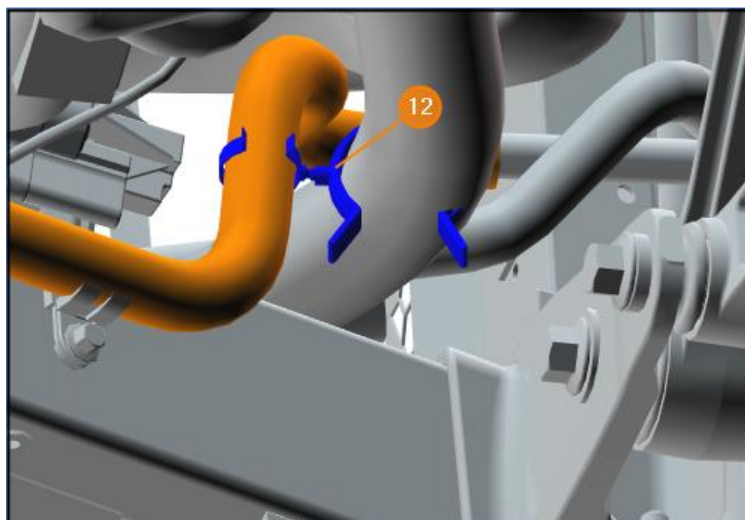
Through continuous product quality monitoring, it has been identified that a number of McLaren 720S vehicles (Coupe and Spider versions) may have an insufficient gap tolerance between the Clutch Cooler Hose and the Turbocharger Wastegate. This could cause damage to the components; therefore, a preventive rework solution has been released.

Layout overview - Clutch Cooler Hose with clip assembly (12) installed
(extract from SCB 14 L 003 WI)

- Check the part number of the installed Clutch Cooler Hose and replace if necessary (if a P13 part is installed, replace hose)
- Install a double 'C' clip which will increase the gap tolerance

CARE POINT: If the required gap tolerance still cannot be met, replace the Clutch Cooler Hose. Do not adjust the hose position at the front hose clamp end as the required tension will not be met.
