# McLaren 720S and 765LT – Clutch Cooler Hose Clash Rework

**Bulletin type:** Service Campaign Bulletin  
**Reference number:** SCB14 L 003 (V2)  
**Attention:** Retailer Service Managers and Retailer Technicians  
**Affected vehicles:** 720S Coupe and Spider, 765LT Coupe  
**Situation:** Potential for insufficient gap tolerance between components  
**Procedure:** To action affected vehicles during next Retailer visit. Please refer to the information outlined in this document to ensure required gap tolerance is achieved  
**Date:** 21<sup>st</sup> January 2021

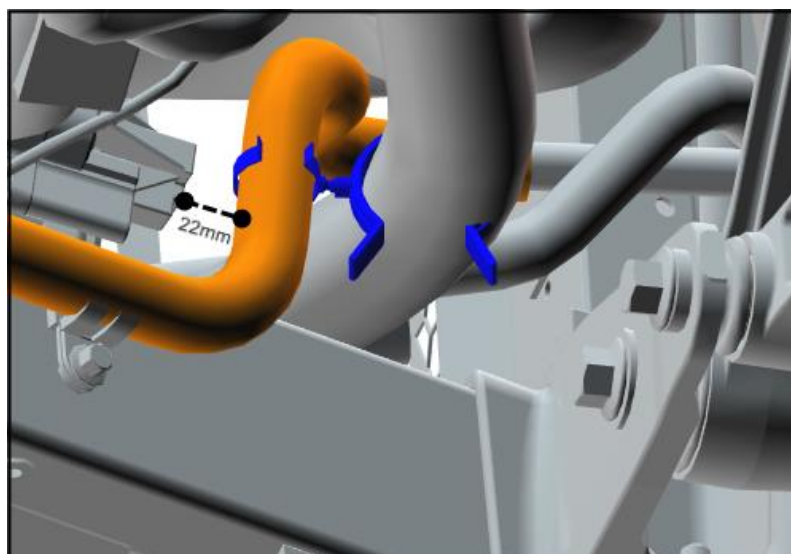
Through continuous product quality monitoring, it has been identified that a number of McLaren 720S vehicles (Coupe and Spider versions) and 765LT Coupe, may have an insufficient gap tolerance between the Clutch Cooler Hose and the Turbocharger Wastegate. This could cause damage to the components; therefore, a preventive rework solution has been released.

Example: Clip assembly installed with min. clearance tolerance to achieve

- Check the part number of the installed Clutch Cooler Hose and replace if necessary (if a P13 part is installed, replace hose)
- Install a double 'C' clip which will increase the gap tolerance

**CARE POINT:** If the required gap tolerance still cannot be met, replace the Clutch Cooler Hose. Do not adjust the hose position at the front hose clamp end as the required tension will not be met.
