Location: Body & BIW – Active Aero

Topic: Airbrake warning displayed on the instrument cluster

C111492 - Airbrake Twist

C101B09 - Airbrake System Failure

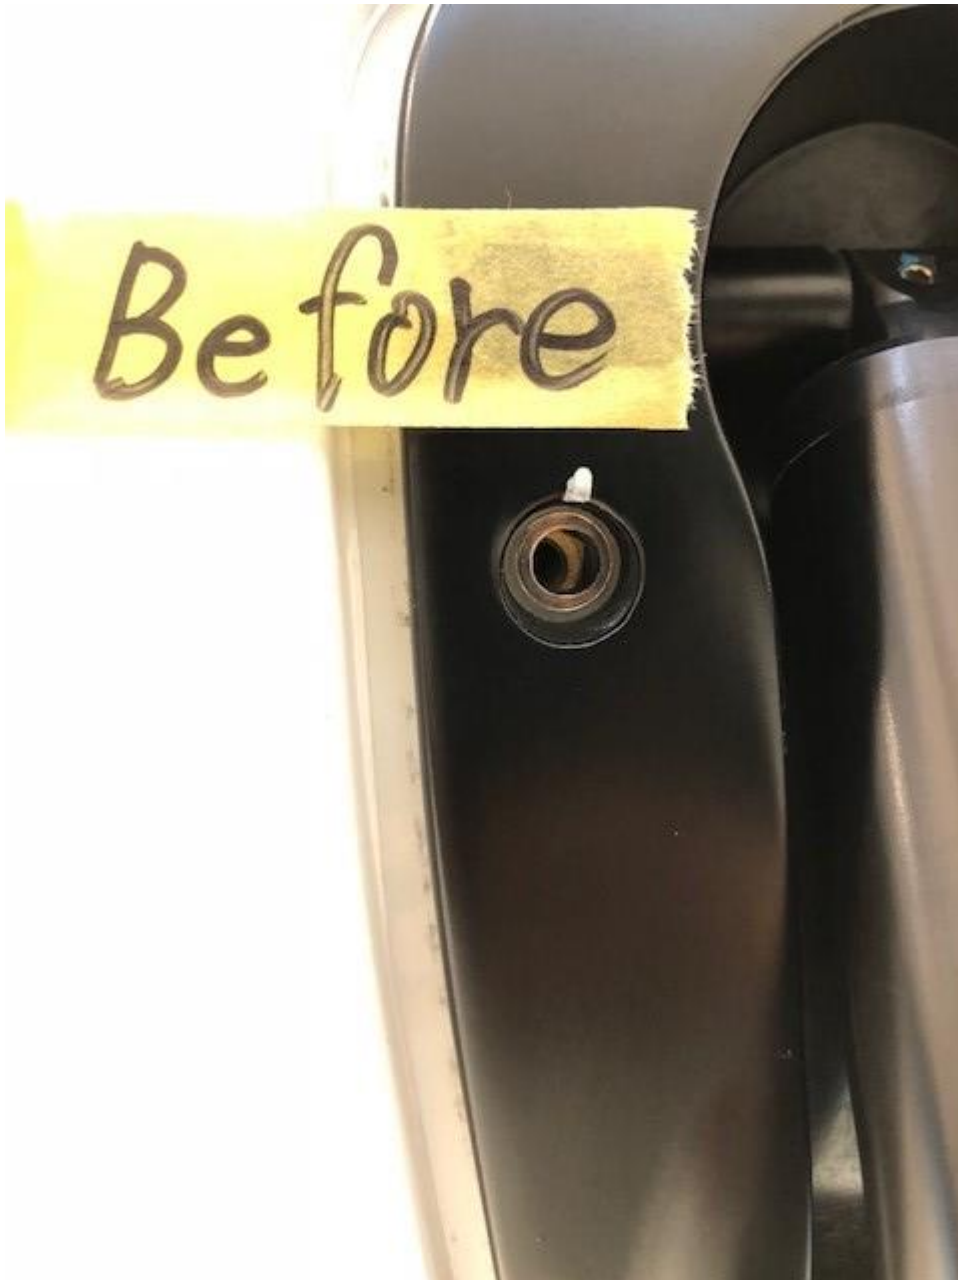
In the event of a customer complaint for Airbrake Warning Message on the instrument cluster and the Airbrake Twist DTC C111492 is present in the PCCU, it is possible that the airbrake actuators are not running parallel to each other. This will cause increased drag and a twist condition in the airbrake panel.

1. Remove the airbrake panel fixing bolts of the right hand side actuator only.
2. Check if the holes of the airbrake panel with the hole of the actuator line up. If ok, reinstall the bolts and remove the bolts of the opposite side (left hand side).
3. If the holes do not line up as shown in the image below, is possible that the airbrake actuators are not parallel and require shimming.

Figure 1: Airbrake panel holes not aligned.

4. To do this insert shims between the airbrake actuator mounting and the subframe. Different thickness shims are available via SPC (screenshot below).
