**Location:** Chassis - Suspension

**Topic:** Multiple warnings on the driver's display and unable to use nose lift and perform mode changes.

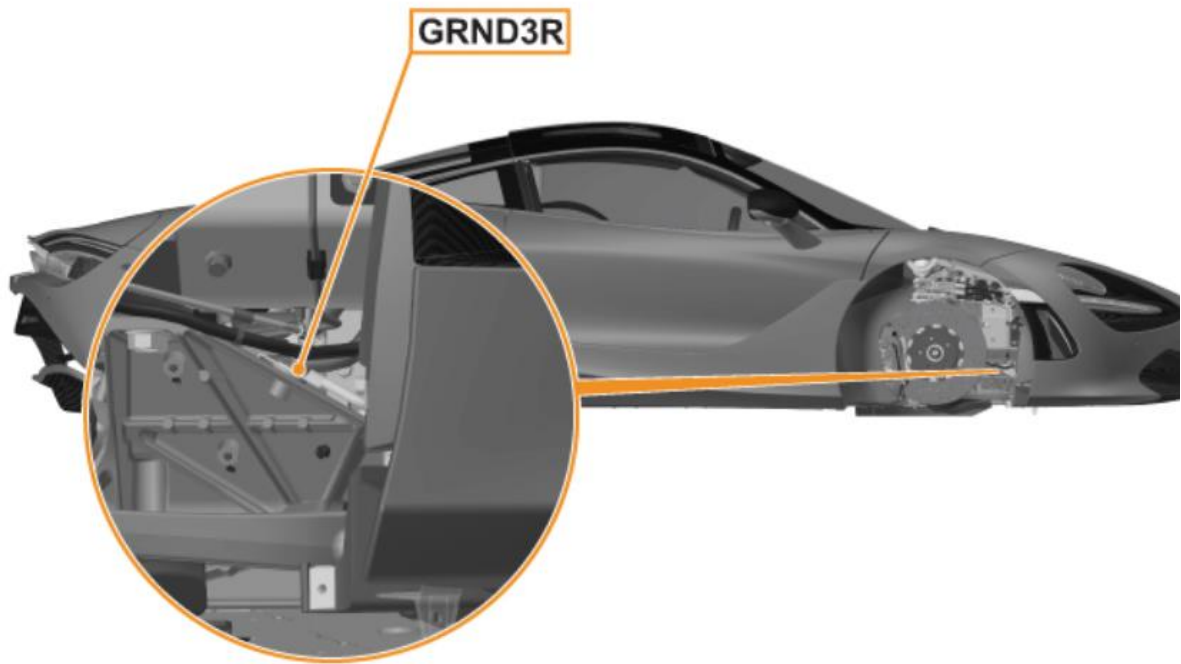
GRND38

Poor ground(s) contact may have caused the CCU to remain in sleep and as a result most of the powertrain and chassis control units have lost communication with CCU.

1. Connect the MDS and confirm if various control units have DTCs for no communication with the Chassis Control Unit (CCU). If yes, proceed to the next steps. If no DTCs for loss of communication with the CCU are recorded, this MTI is not applicable.
2. Locate the three grounds GRND1, GRND38, GRND3R (refer to attachments for images)
